JS|HELD

WHITE PAPERS &  
RESEARCH REPORTS

## Fourier-Transform Infrared (FTIR) Technology & Analysis

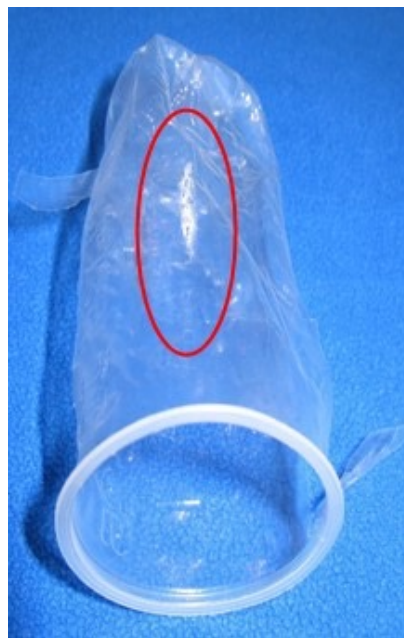
A manufacturer of disposable plastic baby bottle liners began receiving reports from consumers of contamination on the liners. Mold was initially suspected but ruled out after mycological analysis. Samples of customer returns and unopened boxes of production liners were obtained for analysis. An initial inspection showed two different types of contamination: light colored deposits as shown in Figure 1 and dark spots as shown in Figure 2.

**Figure 1** - Wax-like contamination on the surface of polyethylene plastic baby bottle liners.

In plastics manufacturing, sheets of plastic or, in this case, the plastic liners, can stick together during processing. In order to mitigate this condition, additives, called slip or anti-block agents, are often used to lower the coefficient of friction so the plastic parts are able to slip past one another more easily. Erucamide, a waxy substance derived from rapeseed oil, and/or fine clays or talc are incorporated into the plastic and act as lubricants or anti-block agents. Only the additive that is present at the surface of the plastic sheet is effective as a slip or anti-block agent. Much of the clays and talc remain buried in the bulk of the plastic and are ineffective, whereas

erucamide will “bloom” lightly to the surface but the concentrations will be so low as to not be visible. However, when excessive amounts of processing aids such as lubricants and slip compounds are used and/or a higher density resin is used than was intended, (e.g., HDPE instead of LDPE), the additives can form deposits on surfaces of molds, dies, or other processing equipment and later slough off on to the plastic during production. The phenomenon is known as “plate-out” or “die drool.” Figure 6 shows an extreme example of the buildup on the die of a plastic sheet extrusion machinery die. It was concluded that erucamide/anti-oxidant plate-out residue had accumulated on the die and deposited on the thin sheets that were later thermoformed into the baby bottle liners.

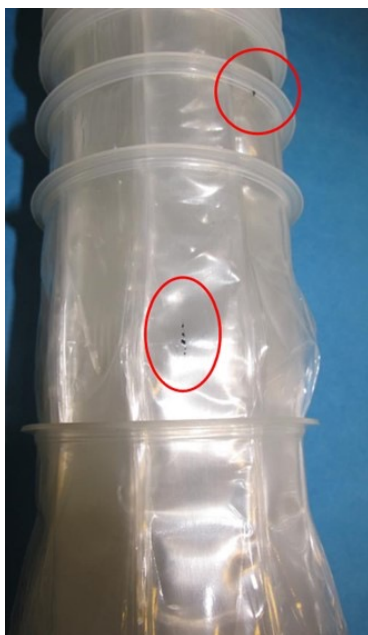
**Figure 2** - Black contamination on the walls of the liners.

The black spots seen in Figure 2 were examined under a dissecting microscope and determined to be embedded within the polyethylene liners and not on the surface of the material. Figure 7 shows one of the embedded black spots in cross-section after it was transected with a scalpel.

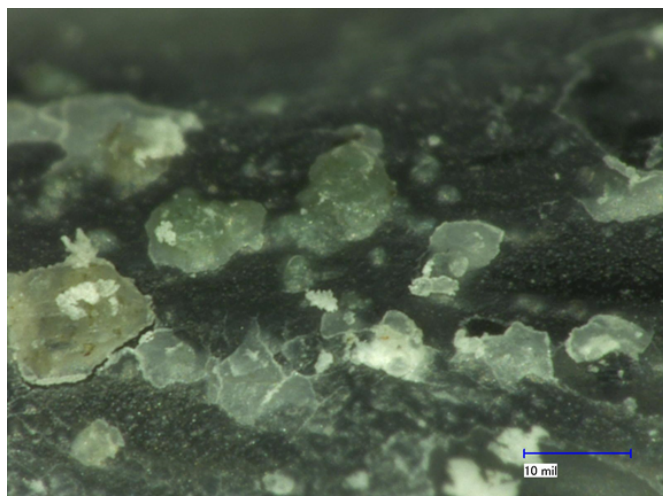
A small fragment (5/1000 inch) of the lighter colored contaminant, shown in the microscope view in Figure 3, was analyzed by FTIR and identified as containing phenyl phosphite (Figure 4), an anti-oxidant commonly used in processing of polyethylene (PE) to prevent thermal degradation at high temperatures. The FTIR spectra also contained extra peaks not associated with the antioxidant as shown by the red markings in Figure 4.

**Figure 3** - Deposit on the surface of the baby bottle liner seen under digital microscope at 200 times magnification.

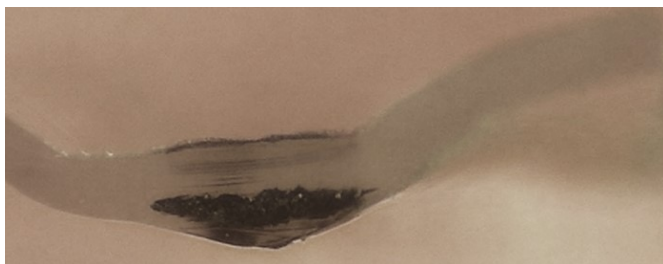
**Figure 7** - Cross section of black particle and liner showing that it was embedded in the bulk of the polyethylene liner.

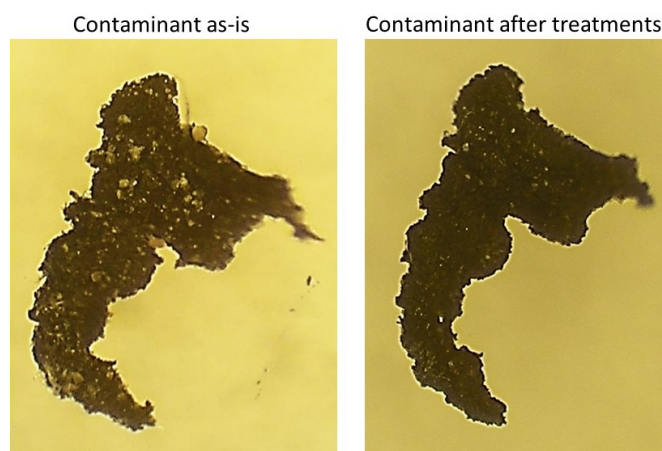
The black particles had a rubber-like consistency. FTIR analysis of the black spots did not positively identify the rubber-like material as it was masked by the numerous crystalline particles which overwhelmed the signal. The spectra indicated that the crystals were calcium carbonate, a common filler used in rubbers to improve their physical properties. FTIR spectral subtraction was attempted as before but the results were inconclusive. A small amount of hydrochloric acid (HCl) was added to one of the particles to remove the calcium carbonate. HCl will dissolve calcium carbonate resulting in carbon dioxide gas and a water soluble salt that can be rinsed away leaving the rubbery material in isolation. Figure 8 shows digital microscope images of one black particle before and after the HCl treatment and rinsing. Note the large number of crystals in the as-is or pre-treatment image (left) and the relative lack of crystals in the post-treatment image (right).

**Figure 8** - Extracted black particle before (left) and after HCl treatment and rinsing with water (right).

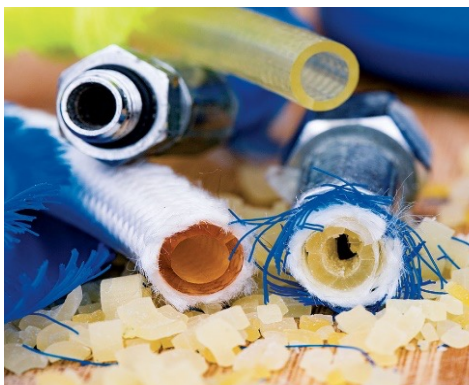
Reports described scuba air hoses failing internally and plugging up regulators that deliver breathing air to the diver. The failed hoses ranged in age from about 3-8 years and were generally located in tropical areas. The braided hoses showed no outward sign of deterioration; however, when the hoses were cut open, deterioration to the internal rubber hoses was clearly visible (Figure 10 and Figure 11).

**Figure 10** - TPU scuba air hoses at various stages of degradation.

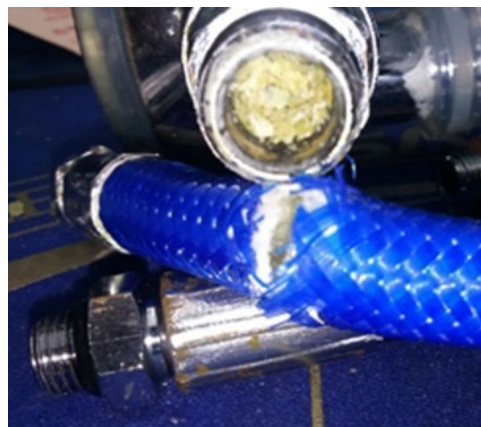
**Figure 11** - Severely degraded TPU hose clogging air hose.

This distinction is important because TPUs with ester linkages (polyester TPU) are known to be susceptible to hydrolytic degradation while TPU with ether linkages (polyether TPU) are much more resilient to this type of decay. Testing and analysis showed that the combination of moisture in contact with the rubber hoses, the higher temperatures found in tropical environments, and, critically, the use of polyester (versus polyether) type TPU material for the hoses caused the rapid deterioration and failure of the scuba air hoses. Even though both air tubes were made from TPU, the specific polymer chemistry chosen to make the failed tubes was inappropriate for the application, being highly susceptible to environmental degradation and potentially leading to clogging of the second stage regulator of a scuba diver, in turn leading to loss of air supply. Consequently, the Consumer Products Safety Commission (CPSC) was notified, and corrective measures have been taken to address the issue.

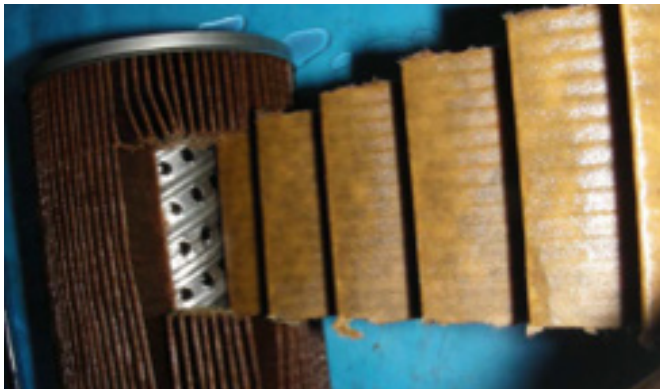
**Figure 15** - Secondary fuel filter section removed for examination.

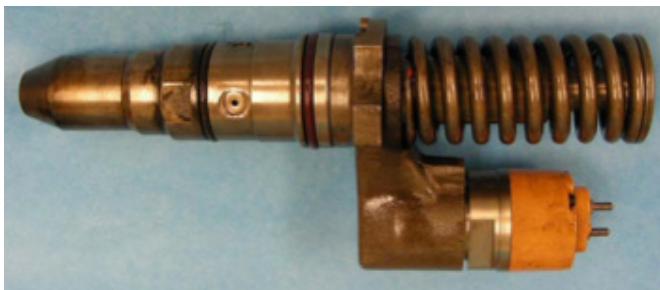
Incident fuel filter and fuel injectors were obtained for examination (See Figure 15 and Figure 16). Disassembly of the injector proved difficult as the needle valves were stuck in their housings. Once taken apart, wax-like deposits were observed on the solenoid piston (Figure 17) and light-colored deposits were observed on the surfaces of the solenoids, needle valves, and needle valve housing bores as shown in Figure 18 and Figure 19. FTIR and SEM-EDS analyses were performed to provide chemical structure information and elemental composition of the deposits.

**Figure 16** - Clogged fuel injector from one of the vessel's diesel engines.

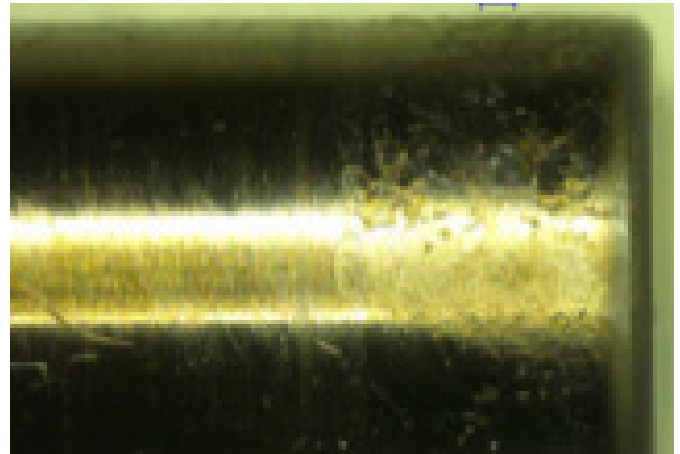
**Figure 17** - Blunt end of needle valve from injector showing deposits, 50X magnification.

It was concluded that the soap deposits were likely responsible for the improper function of the injectors. Additional information regarding fuel processing and fuel additives led to the conclusion that the formation of the soap deposits was likely the result of two classes of contaminants in the fuel—acidic corrosion inhibitors; introduced during the refining, storage, and/or transport process prior to delivery to the vessel; and sodium and/or calcium. Possible sources of sodium and/or calcium include contamination from sea water, salt-dryer filters used in the processing and refining of fuel, and chemicals used for cleaning the vessel’s fuel tanks. The third component that combined to form the soap deposits is the diesel fuel itself and/or biological growth (if water is present in the fuel). The soap formed was viscous and highly polar, capable of adhering to metal surfaces and “gumming up the works.” The presence of copper and zinc can accelerate such a process. Standard fuel tests currently in use were not effective for identifying the cause of the problem because the quantity of contaminants necessary for carboxylate formation which cause the injector failure was extremely small. The immediate solution to prevent injector failure was to prevent or remove formation of the deposits rather than try to identify the presence of contaminants in the fuel.

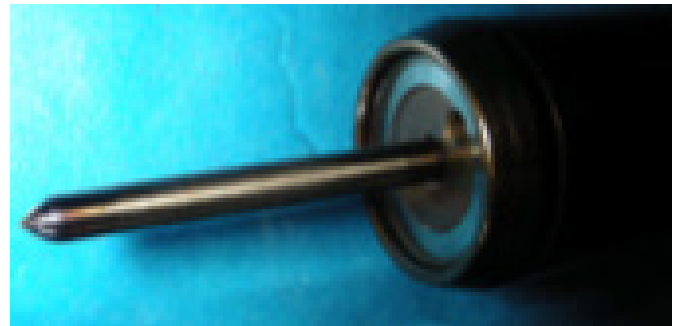
**Figure 18** - Fuel injector with needle stuck in the injector bore.

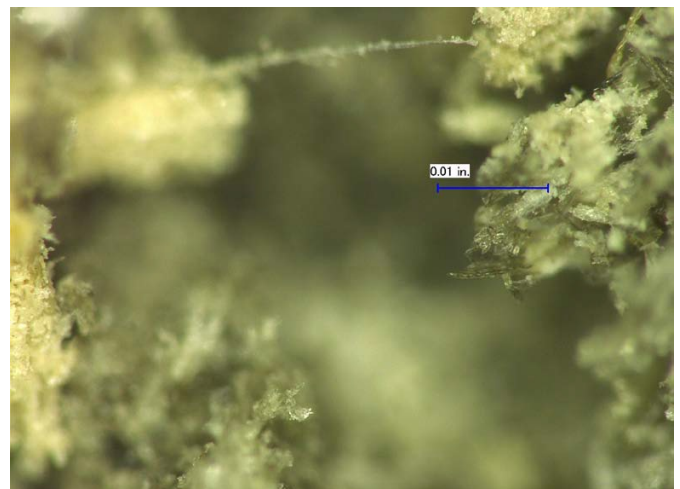
**Figure 19** - Scrapings from needle valve housing (bore), 200X magnification.

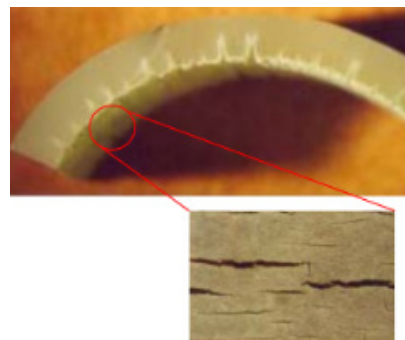
Many different types of pipes are used in potable water service. Often, claims involve premature failure of polyethylene (PE) and cross-linked polyethylene (PEX) pipes used in household domestic water systems. Figure 21 shows a severely degraded PE water pipe in cross-section with cracks on the inner wall surface. FTIR can be a powerful tool in the analysis of PE and PEX when determining degradation.

**Figure 21** - Severely degraded inner surface of polyethylene water pipe.
