# A Comparison of 25 High Speed Tire Disablements Involving Full and Partial Tread Separations

Gray Beauchamp, Daniel Koch and Dana E. Thornton  
Kineticorp LLC

**CITATION:** Beauchamp, G., Koch, D. and Thornton, D., "A Comparison of 25 High Speed Tire Disablements Involving Full and Partial Tread Separations," *SAE Int. J. Trans. Safety* 1(2):2013, doi:10.4271/2013-01-0776.

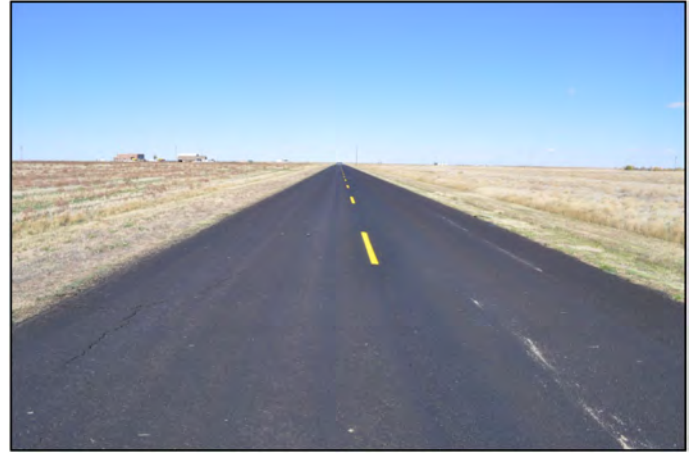
**Figure 3. Test Site After Resurfacing**

The test location in this study was a controlled access roadway that was regularly maintained and free of major defects. The asphalt roadway consisted of two opposing lanes of travel separated by a dashed yellow lane line. The roadway was bordered on either side by a downward sloping earthen shoulder. The length of the roadway was 2.1 miles and was relatively flat. The test surface had been resurfaced within the span of our testing. [Figure 2](#) depicts the surface prior to resurfacing. [Figure 3](#) depicts the testing site after the resurfacing. Weather conditions during each test day are summarized in [Table 1](#).

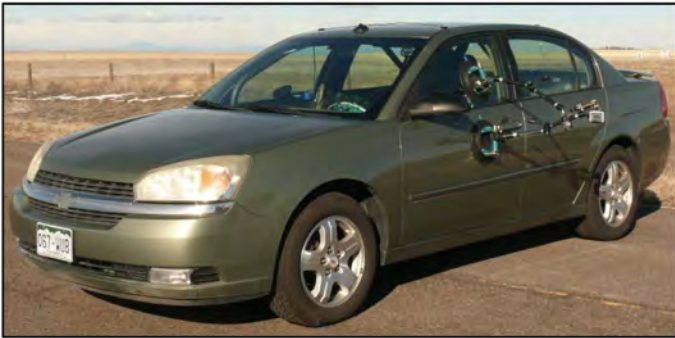
**Figure 4. Test Chevrolet Malibu**

The four-door, 2004 model year Malibu LT was equipped with a 3.5-liter, 6-cylinder gasoline engine and a four-speed, front-wheel-drive automatic transmission. The Malibu has independent front and rear suspension. At the time of testing, the vehicle weighed approximately 3,270 pounds including instrumentation and driver, with a 64% front weight distribution. Prior to testing, the Malibu was inspected at a service center and was found to be in roadworthy condition. [Figure 4](#) depicts the Malibu.

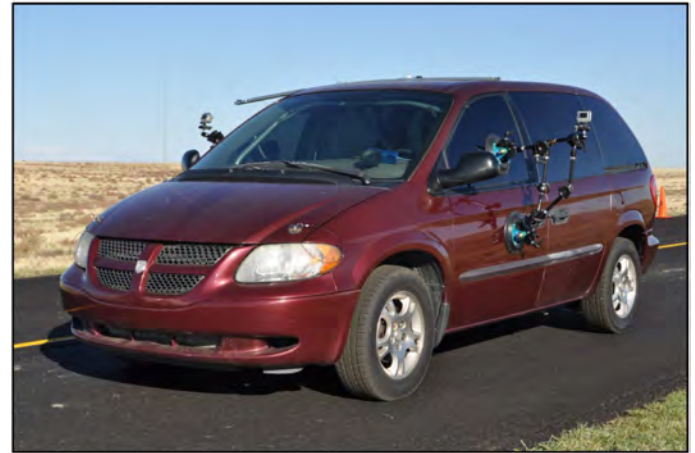
**Figure 6. Test Dodge Caravan**

The 2003 model year Caravan SE was equipped with a 3.3-liter, 6-cylinder gasoline engine and a four-speed, front-wheel-drive automatic transmission. The Caravan has independent front suspension and a live rear axle. At the time of testing the vehicle weighed approximately 4,026 pounds including instrumentation and driver, with a 59% front weight distribution. The Caravan was inspected and driven prior to testing and found to be in roadworthy condition. [Figure 6](#) depicts the Caravan on the day of the testing.

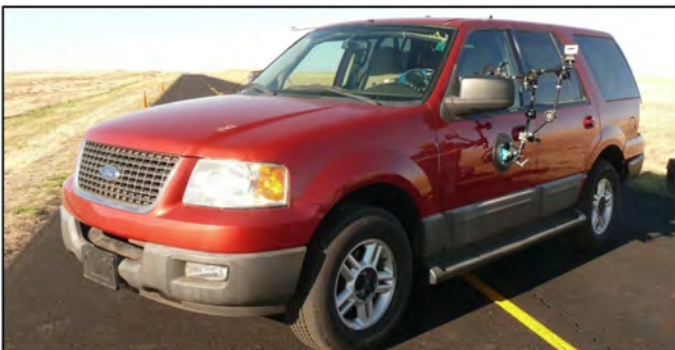
**Figure 5. Test Ford Expedition**

The 2003 model year Expedition XLT was equipped with a 4.6-liter, 8-cylinder gasoline engine and a four-speed, rear-wheel-drive automatic transmission. The Expedition has independent front and rear suspension. At the time of testing, the vehicle weighed approximately 5,425 pounds including instrumentation and driver, with a 49% front weight distribution. Prior to testing, the Expedition was inspected at a service center and was found to be in roadworthy condition. [Figure 5](#) depicts the Expedition on the day of the testing.

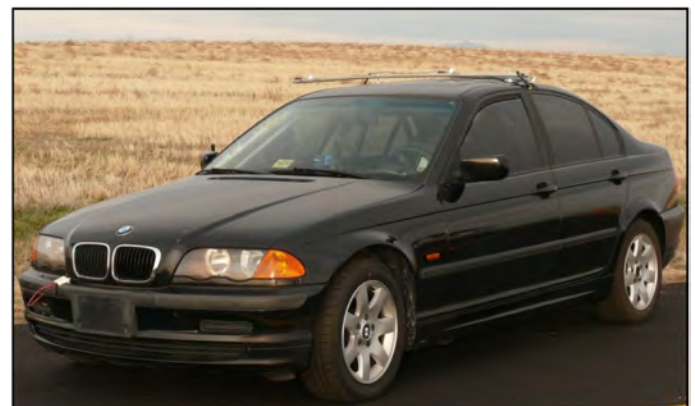
**Figure 7. Test BMW 323i**

The 1999 model year BMW was equipped with a 2.5-liter, 6-cylinder gasoline engine and a four-speed, rear-wheel-drive automatic transmission. The BMW has independent front and rear suspension. At the time of testing, the vehicle weighed approximately 3319 lbs including instrumentation and driver, with a 51% front weight distribution. The BMW tested was equipped with electronic stability control (ESC). Prior to testing, the BMW was inspected at a service center and was found to be in roadworthy condition. [Figure 7](#) depicts the BMW on the day of the testing.

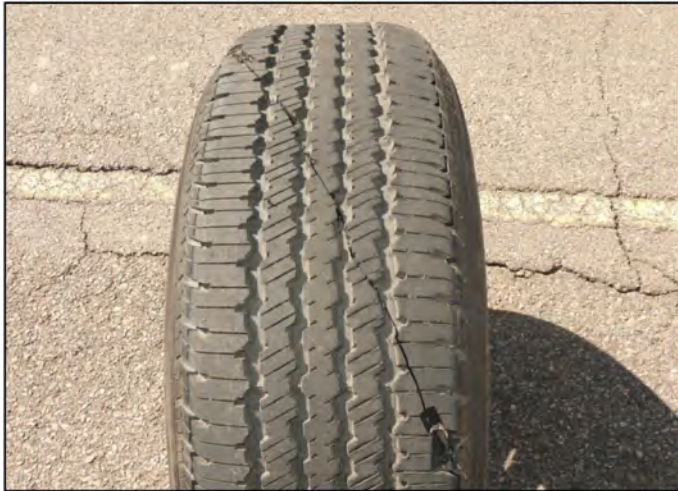
**Figure 8. Example of bias cut across tread**

A variety of tires from different manufacturers were used in the testing. Tires were prepared to facilitate the tread and top belt separating, either fully or partially. First, a single cut was made across the tread of the tire along the belt bias. This cut went through top nylon cords, as depicted in [figure 8](#). The shoulder on both sides of the tire was then cut around the entire circumference for full tread separations or around a portion, either 90 degrees or 180 degrees, for partial

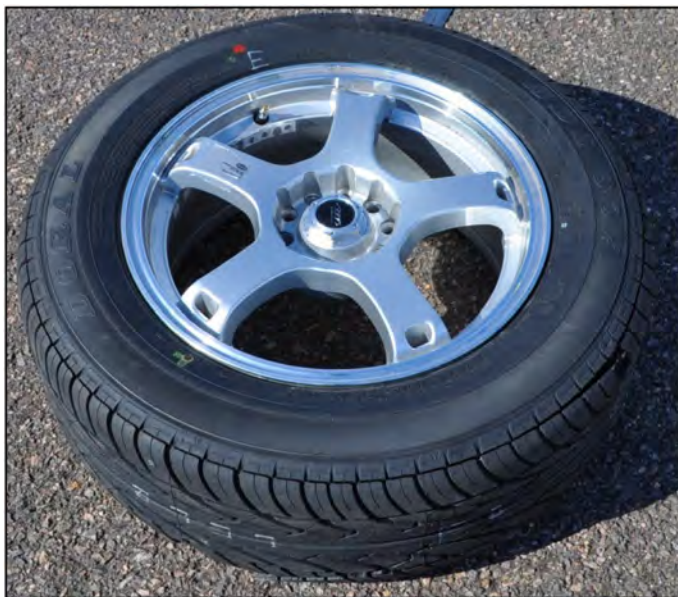
**Figure 9. Example circumferential shoulder cut**

separations, as depicted in [Figure 9](#). Cut depths into the shoulder were on the order of two inches, which initiated tread separations at highway speeds. For the Malibu, Expedition and Caravan tests, the tires were prepared to facilitate tread separation in the leading direction. In other words, the tread was cut so that the tread would peel off of the tire in the direction opposite of rotation, as depicted in [Figure 10](#).

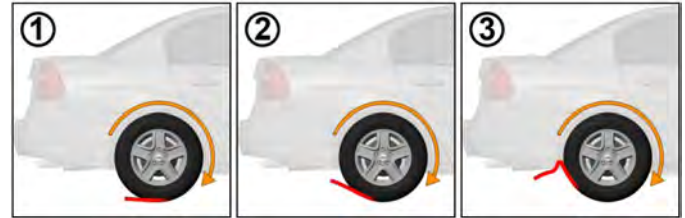
**Figure 10. Leading/peeling separation**

For the BMW, one tire was prepared for a full tread separation using the procedure discussed above. Several tires were prepared to partially separate in both the leading/peeling and the trailing/lifting direction. [Figures 10](#) and [11](#) graphically depict the difference between leading and trailing separations. In [Figures 10](#) and [11](#), the vehicle is traveling from left to right across the page, from position 1 to 3. In

both [Figures](#), the tread flap, which is in the process of separating, is indicated in red.

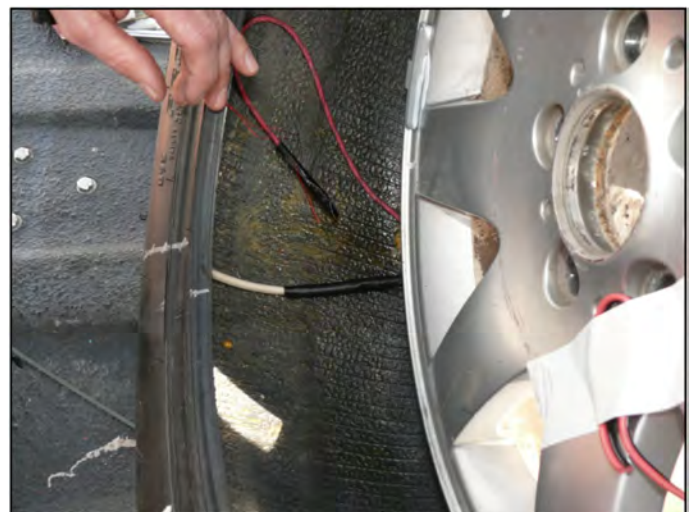
**Figure 12. Detonation cord on the interior of the tire**

Several tires were prepared to facilitate partial separation and air loss. In order to cause rapid air loss, detonation cord was placed on the inside of the tire across its width. The explosives were set so that they could be remotely detonated once the vehicle reached the desired test speed, or alternatively, to detonate after the tread separation had initiated. The amount of explosive chosen, determined through testing of stationary tires, was enough to deflate air rapidly without damaging the vehicle. [Figure 12](#) depicts the detonation cord on the interior of one of the test tires. [Figure 13](#) depicts a mounting bracket on the exterior of the rim that held the receiver in place. The trigger remote is depicted in [Figure 14](#), affixed to the steering wheel of the test vehicle.

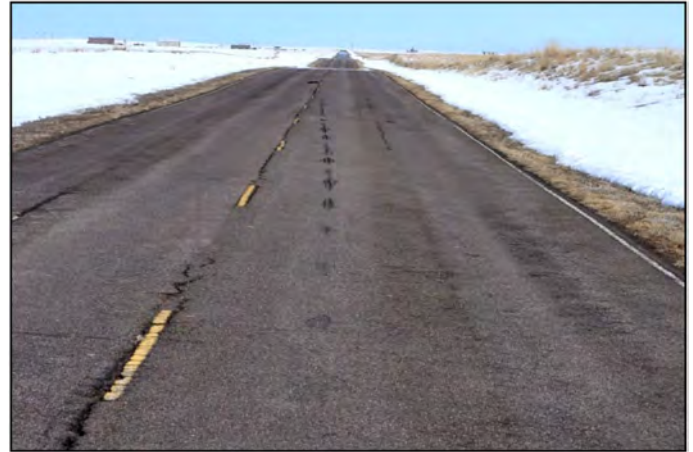
*Figure 15. Tire mark from a full tread separation test*

Following each run, the physical evidence deposited on the roadway was documented. During each test, a single tire mark was deposited by the separating tire. The marks were irregular and non-continuous, consistent with the tread flap striking the ground. When the tread released from the tire, the tire mark ceased. IF the tread flap remained attached, the tire mark continued until the vehicle speed reduced considerably. When air loss occurred, the tire mark was noticeably different. Specifically, the mark was still irregular, but more continuous than when the tire retained air pressure. When air loss occurred, the edges of the tire mark were darker, as a result of point loading from the rim. [Figure 15](#) depicts a tire mark from a full tread separation test. As depicted, the tire mark ends, corresponding to the release of the tread. The tread can be seen in [Figure 15](#), beyond the tire mark. However, the end location of the tread didn't necessarily correspond to the location the tread released from the tire. In several tests, the tread became entangled with the vehicle and was carried a significant distance down the roadway before

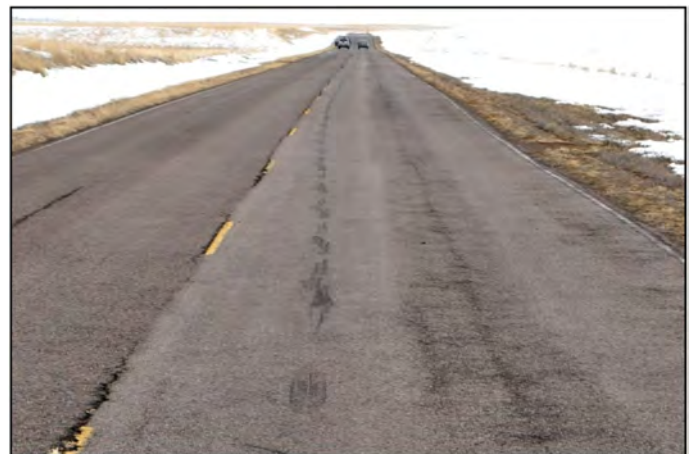
*Figure 16. Tire mark from a partial tread separation*

being deposited. [Figure 16](#) is the mark from a partial tread separation test. The tread remained attached throughout this test and the mark continues until near the vehicle rest position. In [Figure 17](#), the tire lost air during a full separation event. The mark in this case continued beyond the tread flap, as depicted, due to the lack of air pressure.

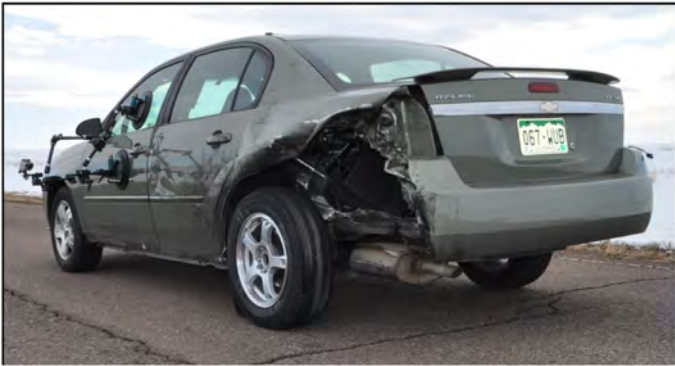
**Figure 18. Damage to Malibu test vehicle**

The damage to the vehicle was documented after each test. Running multiple tread separation events with a single vehicle produced significant vehicle damage, primarily in the rear quarter panel area. The damage was repaired periodically using bailing wire to retain the basic shape of the rear quarter panel. In the Malibu, the rear quarter panel was eventually destroyed completely, so a quarter panel was fabricated from steel sheeting. This modified structure was torn from the vehicle in the final test. [Figure 18](#) depicts the final condition of the Malibu. No identifiable differences in vehicle dynamics were noted for different pretest vehicle conditions. In some tests, the damage to the vehicle as a result of that test was minor, limited to light scuffing. In others, the structure was damaged significantly. However, vehicle movement and subsequent driver steering was minor in all cases. Damage to the vehicle from the tread engagement was not an accurate indicator of vehicle controllability.

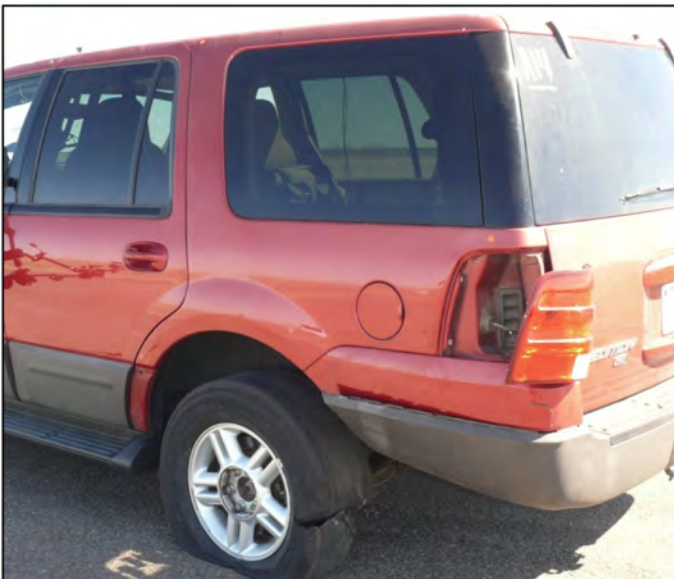
**Figure 19. Ford Expedition following test E01**

The number of tire slap marks on the vehicle was not a good indicator of duration, lane deviation or required steering input. For example, consider the first Caravan test and first

Expedition test. Both disablements were under one second in duration and in both cases the vehicle was kept within its lane with minor steering inputs. Both vehicles exhibited damage to the rear taillights. The Expedition exterior was essentially clean of slap marks after the first test, as depicted in [Figure 19](#). By contrast, the Caravan had extensive slap marks on its exterior, extending from the rear of the vehicle to the sliding door, as depicted in [Figure 20](#). The rear bumper cover and rear tailgate were also dented significantly.

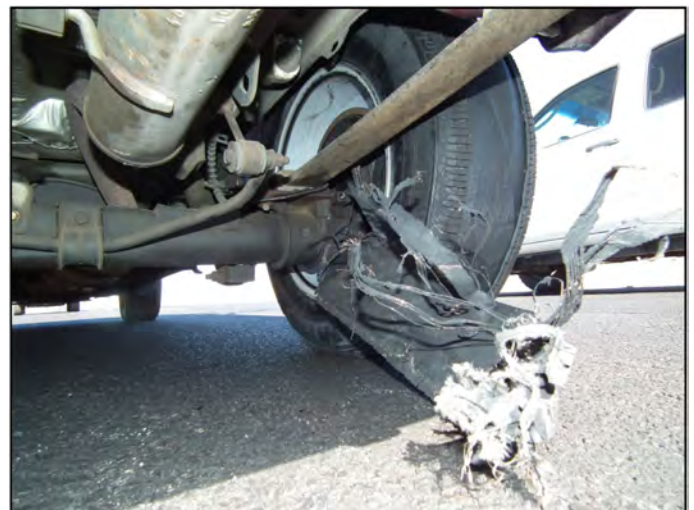
**Figure 21. Tread lodged following test C04**

In test C04, a partial separation with the Dodge Caravan, a portion of the tread became lodged in the axle assembly and the parking brake cable was damaged significantly. The wheel speed sensor was also damaged during this test. [Figures 21](#) and [22](#) depict the tread and parking brake cable, respectively, following the test. The specific effect of the parking brake interaction is unclear. In any case, the vehicle was kept within its lane with steering inputs less than 25 degrees.

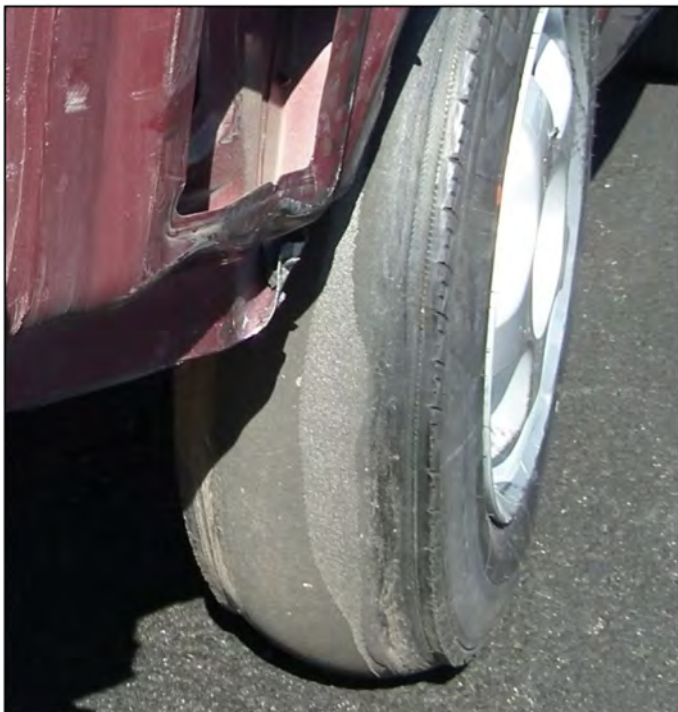
**Figure 23. Tire following a full tread separation test**

In the full separation tests for the Malibu, Expedition, and Dodge, the tread came off of the tire in one piece. During the BMW full separation test, the tread broke into several pieces. Whether the tread came off in one piece or several pieces, the vehicle was kept in its lane with minor steering adjustments. Multiple pieces of tread were not a good indicator of either the duration of the event or controllability. Figure 23 depicts a tire following a full separation. Note that no tread remains on the shoulders of the tire. Tires that were prepared to partially separate varied in their final condition after the tests. For the Malibu testing, the flap remained attached to the tire for the duration of two of the tests. The ends of the flap were

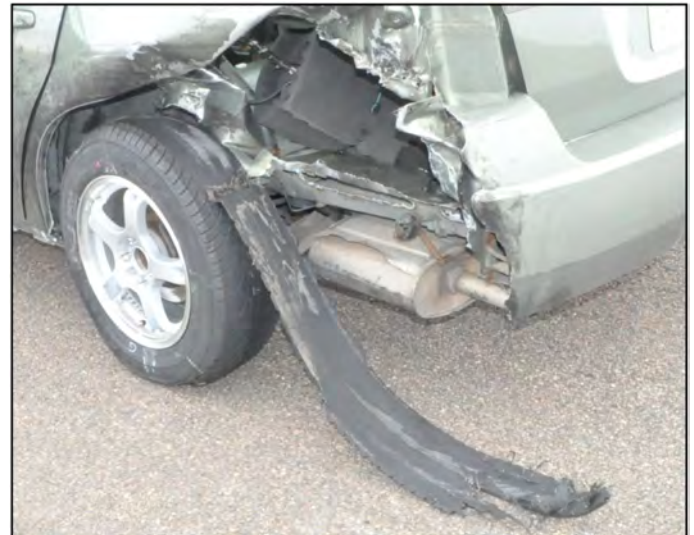
**Figure 24. Tire following a partial tread separation test where the tread flap remained attached**

frayed and damaged extensively, as depicted in Figure 24. In other partial tests, the tread eventually came off the tire around its entire circumference, but portions of the shoulder tread remained attached, as depicted in Figure 25. In other partial tests, the flap detached but 180 degrees of tread remained firmly attached, as depicted in Figure 26. When portions of tread remained on the tire, there was noticeable vibration until the vehicle came to rest. Although the vehicle tracked straight with little or no steering, the driver was aware that there was a problem with the tire following the separation through the vibrational feedback as the vehicle traveled to rest.

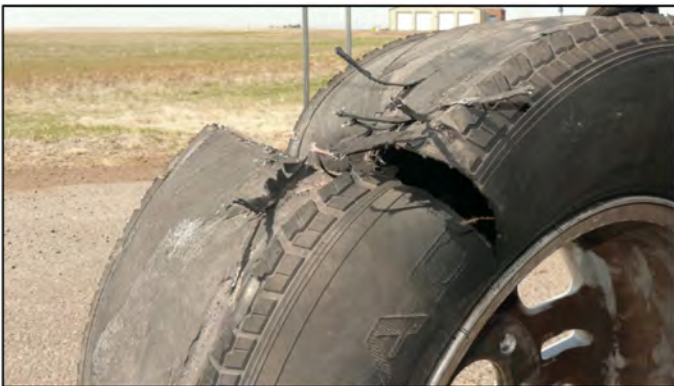
**Figure 27. Tire following a full tread separation with unintended air loss**

During the Expedition test E01, the tire was prepared to facilitate full tread separation. During the early stages of the separation, the tire lost air rapidly. The tire split across the width of the tire and on both sidewalls. [Figure 27](#) depicts the tire from test E01.

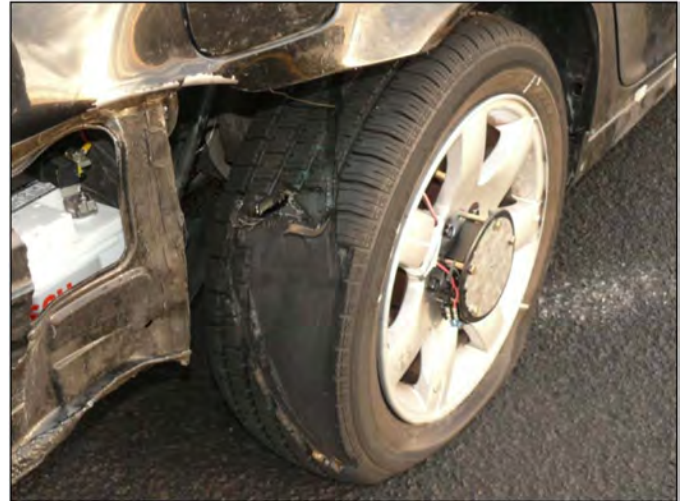
**Figure 28. Tire following a trailing partial separation with air loss**

During the BMW tests, the tires were prepared in a variety of ways, and the post-test tire condition varied as well. [Figure 28](#) depicts the tire following test B06, a trailing partial separation test with air loss. In test B04, the tire was prepared to blowout, initiating a partial separation in the leading direction. More explosives than were required were utilized in this test, resulting in severe tire damage. The outer tread belt did not separate from the tire. Rather, a large hole was blown through the tire, creating a large flap of both belt layers. [Figure 29](#) depicts the tire from test B04. [Figure 30](#) depicts the tire following test B07, a partial separation in the trailing direction. Approximately 90 degrees of tread detached during this test and the tire remained inflated.

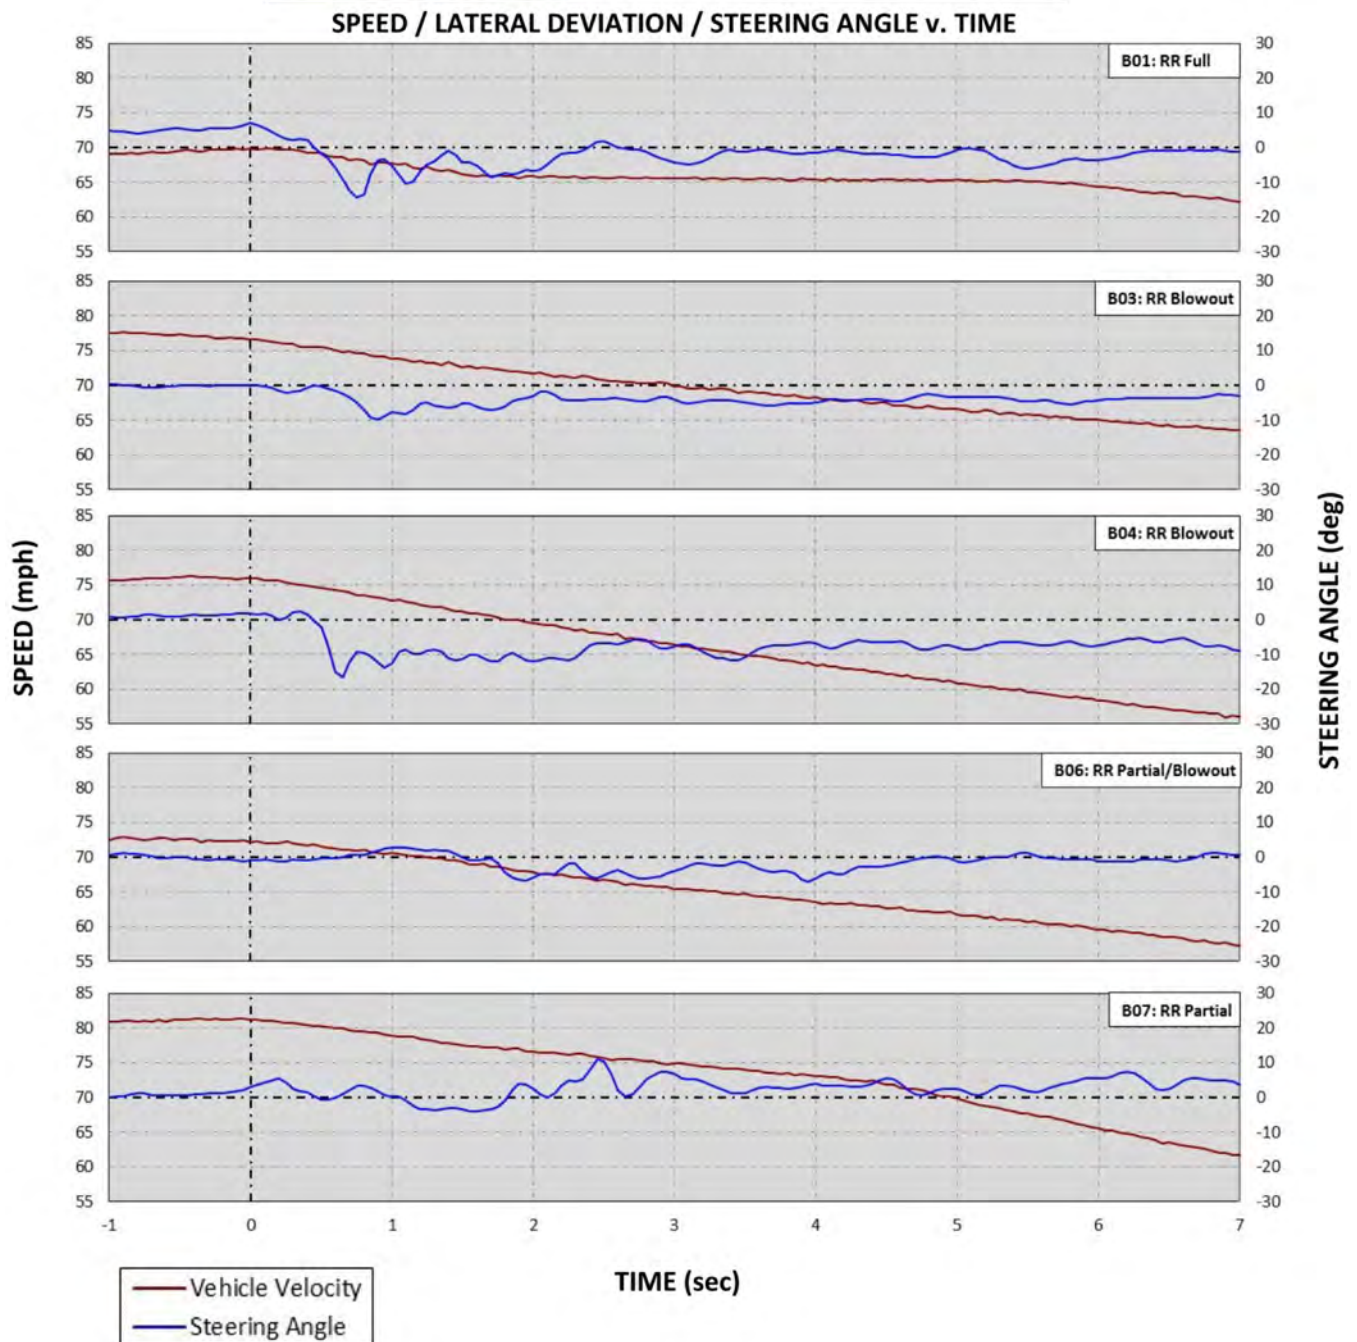
Test Date: 11/01/12  
Vehicle: 2003 BMW 323i  
Vehicle Weight: 3319 lb

Five successful tests were conducted on November 1, 2012. These included a full tread separation, blowout tests, a partial separation, and a partial separation with blowout, all at the rear right position. The blowouts were created using cord explosives placed inside the tire spanning its tread width as discussed earlier. Test speeds ranged between 70 and 81 mph. The full separation lasted 1.6 seconds. Test B03 and B04 were prepared with explosives and pre-cut, such that the driver could accelerate to speed and detonate the explosives, causing a blowout and initiating the tread separation. In B06, the tire was prepared to facilitate a trailing direction partial separation, in which the tread lifted off of the tire in the direction of tire rotation, and also prepared for blowout. In test B06, the driver accelerated to speed until the tire tread began to separate, and then detonated the explosives. In test B07, the tire was prepared to separate partially in the trailing direction. No air loss occurred in test B07. In all runs, the vehicle remained in its lane with steering inputs under 21 degrees. The maximum lateral deviation was 21 inches, and occurred during a blowout. Tests involving blowout required steering in one direction. When the tire remained inflated, successive steering was required when the flap or full tread released. Partial separations in the trailing direction produced minor vehicle lateral motion and the driver kept the vehicle within the lane with steering inputs under 10 degrees. The test results are summarized in the table of [Appendix B](#). [Appendix H](#) includes plots from the BMW tests.
