# PERSPECTIVES

**COMMON PLUMBING  
FITTING INSTALLATION  
DEFICIENCIES AND BEST  
PRACTICES FOR PREVENTING  
WATER DAMAGE CLAIMS**

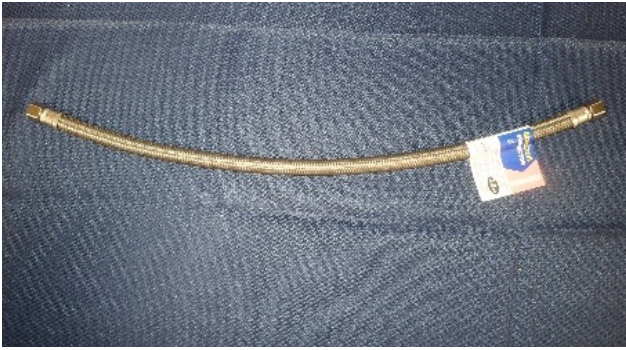
*Flexible faucet connector*

Preassembled flexible connectors are commonly used to connect faucets and toilets to a nearby shutoff valve. They are manufactured by crimping a fitting on each end of a flexible tube, typically ethylene propylene diene monomer (EPDM). The tubing is commonly sheathed with a high tensile strength material, such as nylon or stainless steel, to prevent bursting while under pressure. The fittings typically have captured nuts and polymer gaskets.

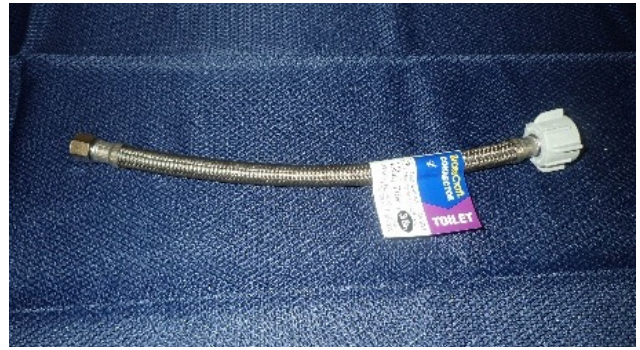
*Flexible toilet connector*

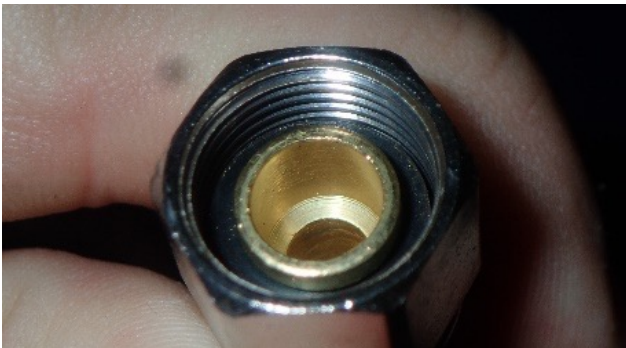
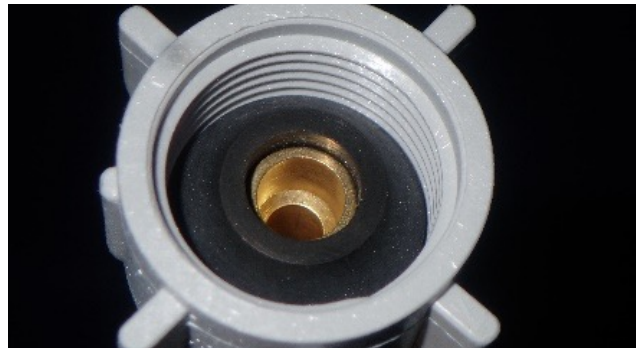
*Compression fitting with polymer gasket*

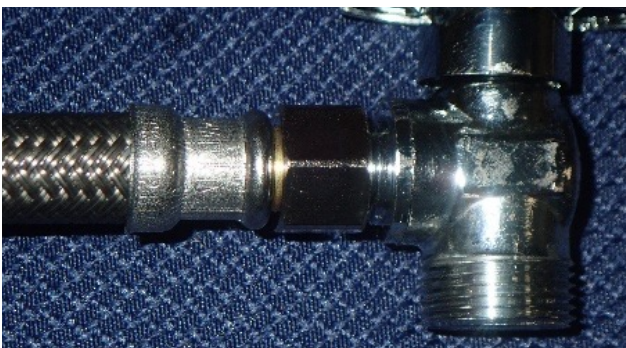
*Flexible connector installed on shut off valve*

Each nut is threaded onto the respective supply valve and plumbing fixture, compressing the polymer gaskets to form a watertight seal. Preassembled flexible connectors are manufactured in varying lengths to fit a range of applications. Common installation errors include:

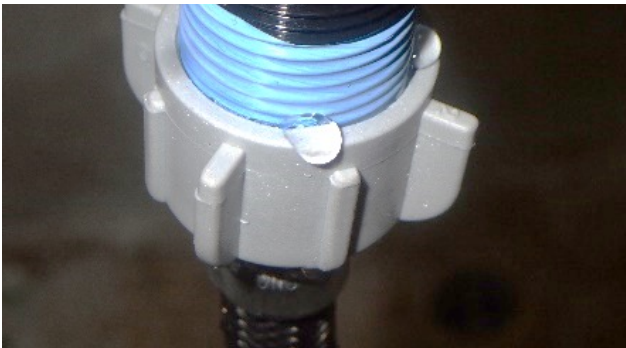
*Thread sealant*

- » Using thread sealants, which can prevent proper tightening of the fitting.
- » Cross threading, preventing proper tightening of the fitting.
- » Overtightening, resulting in gasket or fitting failure.
- » Physical damage caused to the fitting when improperly tightened. Tightening instructions vary by manufacturer. Some fittings indicated hand-tightening only, while others may be tightened using tools but are commonly limited to a fraction of a turn past hand-tight.
- » Under-tightening fittings, which will leak.

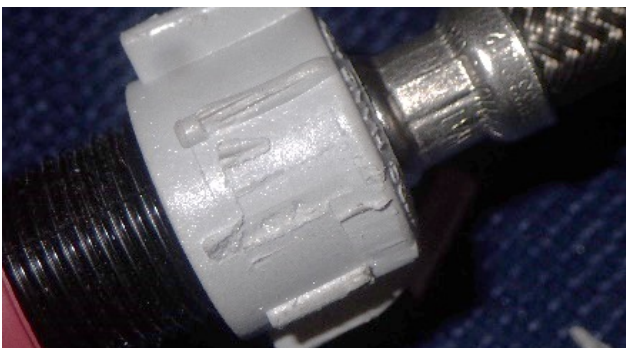
*Overtightening*

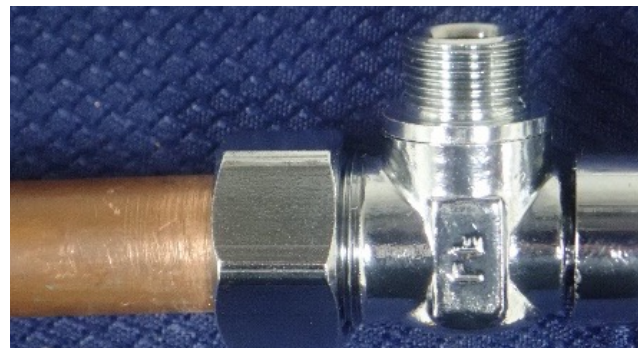
*Copper piping installed*

Although copper piping is less common in new construction, it is very common in older construction. Copper piping is long-lasting, durable, and corrosion resistant. It can be used to connect faucets, toilets, and other appliances to nearby shutoff valves, as well as for longer plumbing runs.

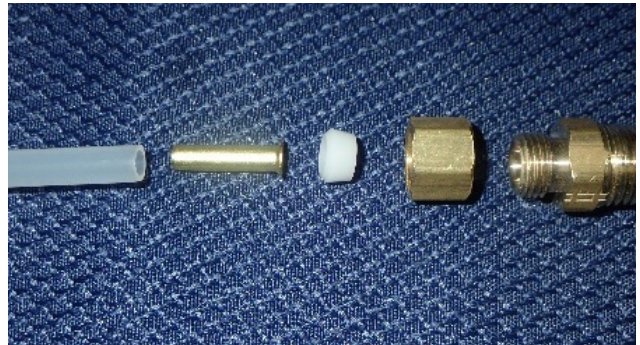
*Exploded compression connection components*

Polyethylene tubing less than 1/2-inch nominal diameter is commonly used for water dispensing applications, such as refrigerators, fountains, and ice makers. Compression fittings for this application consist of a ferrule, a rigid insert, and a compression nut with mating threads on a fitting. The components are sized for the specific tubing diameter. A plastic ferrule is typically recommended, as metallic ferrules can cut into the polyethylene tubing. The rigid insert, typically made of brass, is required to prevent tubing collapse. The ferrule inner surface compresses the tubing against the insert, which both secures the tubing and forms

a seal. The ferrule outer surface compresses onto the fitting mating surface, forming a second seal.

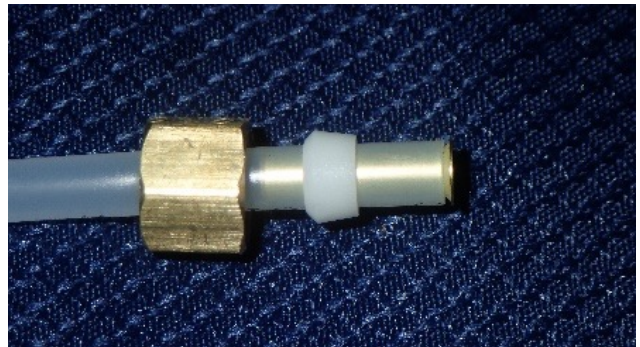
*Preassembled compression connection*

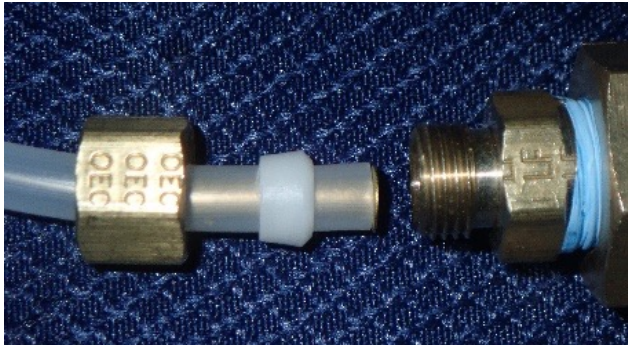
*Incorrect ferrule orientation*

- » Incorrectly orienting the ferrule. The tapered end of the ferrule should point toward the end of the tubing.
- » Not fully inserting tubing into the fitting, which will result in the tubing slipping out of the fitting.
- » Not installing the insert. The polyethylene tubing will deform and fail to seal.

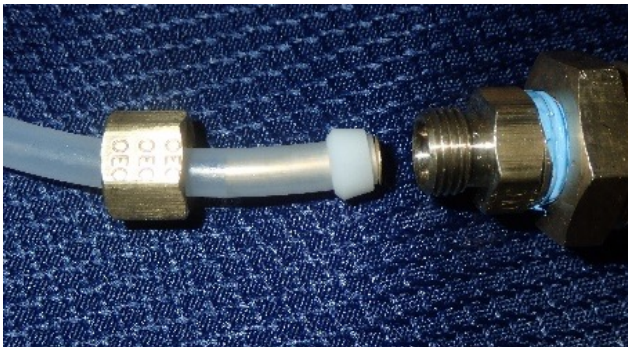
*Insufficient tube insertion*

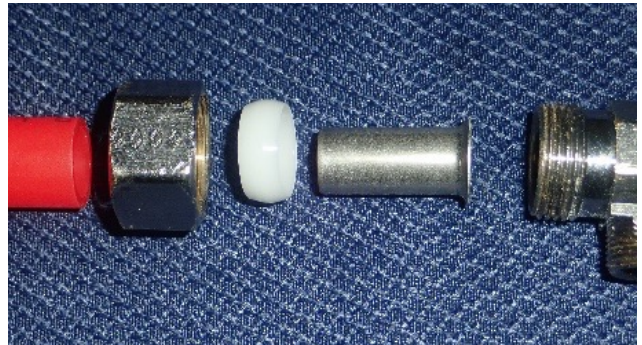
*Exploded view of 1/2-inch nominal PEX-B compression connection components*

While some manufacturers indicate that their compression fittings are suitable for PEX applications, using compression fittings for PEX connections is not common as there are other preferred coupling methods. Compression fittings that are suitable for PEX use may or may not require inserts, depending on the pipe diameter. A plastic ferrule is typically recommended, as metallic ferrules can cut into the PEX tubing. Further complicating the issue is that PEX has three classifications, A, B, and C, depending on the method used to manufacture the product. PEX-B is stiffer than PEX-A, while PEX-C stiffness can vary by manufacturer. All these factors can lead to variations in the tightening of the fitting.

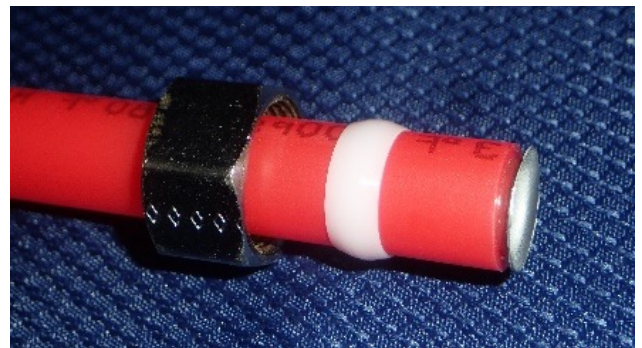
*Preassembled compression connection*

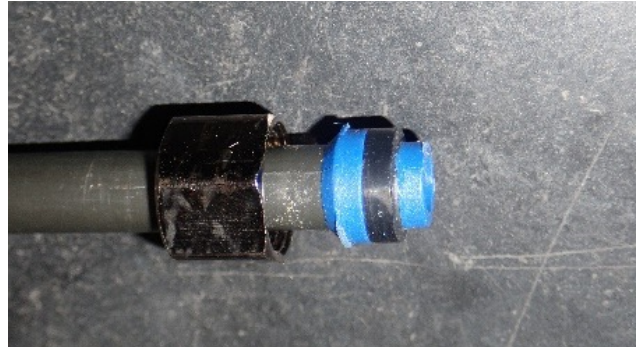
*Factory, preassembled compression connector*

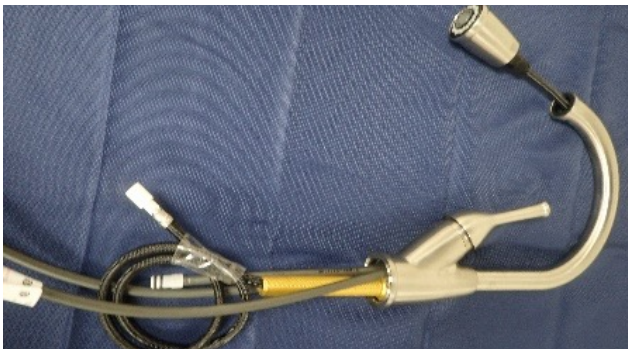
*Faucet with provided, 1/4-inch nominal PEX-C supply lines*

To further speed up installations, some faucet manufacturers have begun producing faucets with preassembled connector lines, typically constructed of 1/4-inch nominal PEX-C. The connectors are of sufficient length to fit a variety of installations. Because the materials differ from the typical preassembled flexible faucet connectors, manufacturers specify that the fitting be tightened significantly more than the typical flexible connector, typically two full turns past hand-tight. Some installers fail to review the manufacturer's instructions for this unique application.

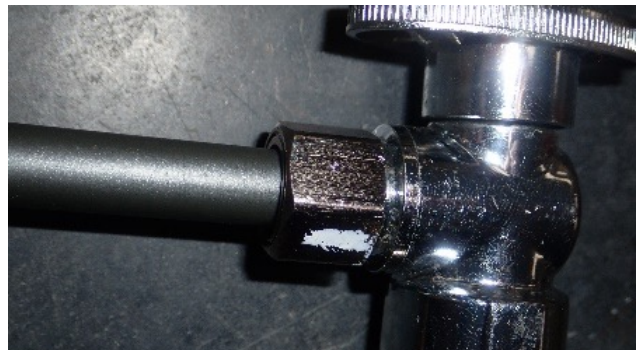
*Preassembled compression connector installed*

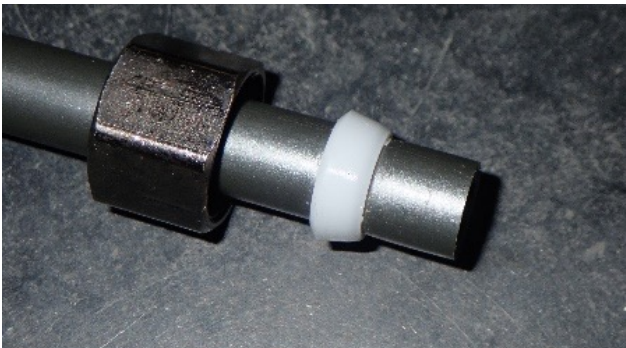
*Insufficiently tightened fitting;  
ferrule loose, tubing will slip*

Further, some installers elect to cut the preassembled lines to a specific length to provide a cleaner fit for the installation. This requires assembly of a compression fitting, which can result in the installation errors previously noted. Failures have resulted when installers incorrectly perform the same tightening procedure as for polyethylene tubing, assuming both materials are the same plastic. However, PEX tubing is significantly stiffer than polyethylene tubing, and the fitting must be tightened according to the manufacturer's instructions to provide sufficient compression.

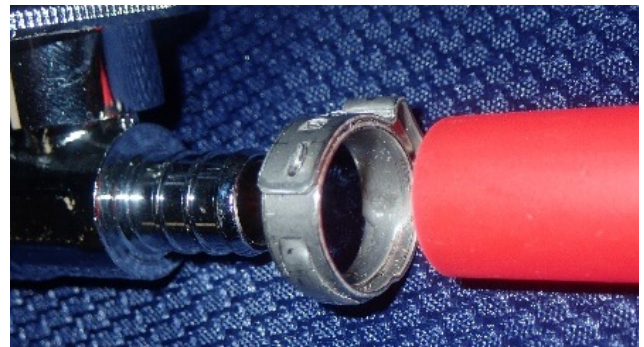
*Exploded view of pinch clamp connection*

PEX is commonly connected by using barbed fittings inserted into the PEX tubing, with a metal pinch clamp, metal crimp ring, or PEX expansion sleeve compressing the piping around the barb. Both pinch clamps and crimp

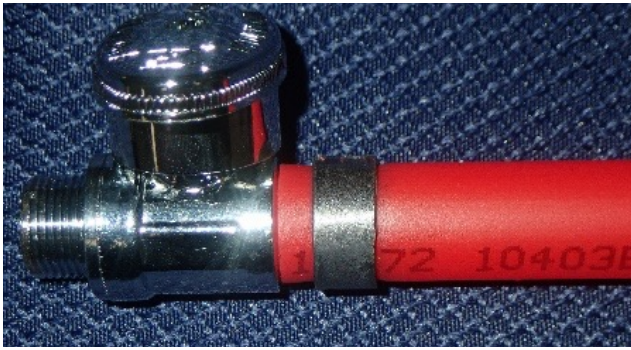
*Completed assembly*

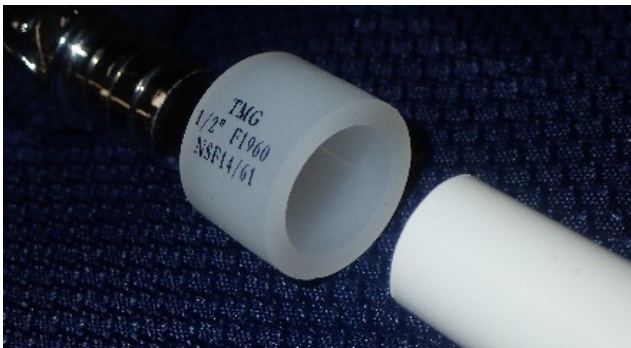
*Exploded view of expansion sleeve connection*

rings require specialized tools which need to be calibrated and maintained to ensure the metal is sufficiently deformed to apply the appropriate compression force. Expansion ring tools do not require formal calibration but do require routine maintenance. Further, selection of the correct expansion tool attachment, which is based on the tubing outer diameter, is critical to ensure the sleeve applies the appropriate compression force once the sleeve material relaxes.

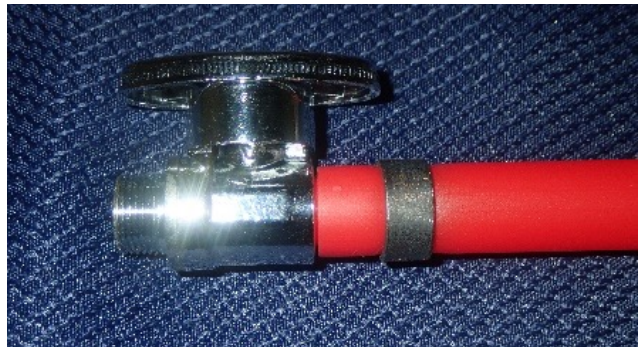
*Crimp ring positioned too far from fitting*

» The ring or sleeve is not centrally positioned over the barb and/or the barb is not fully seated in the PEX tubing. These issues result in poor engagement between the ring/sleeve, PEX tubing, and barb.

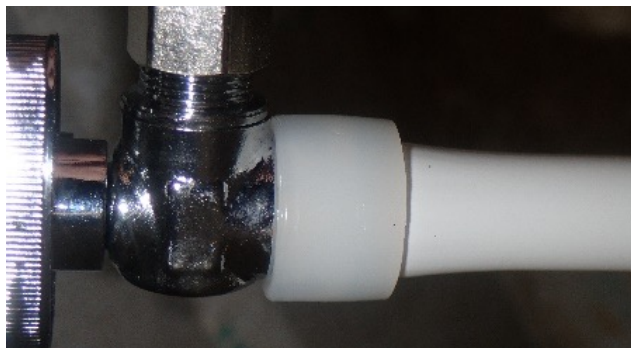
*Completed assembly*

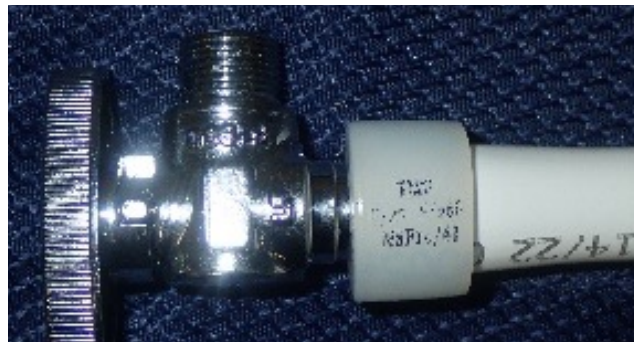
*Barb not fully seated into tubing*
