Deceleration Rates of Vehicles with Disabled Tires

2017-01-1427

Daniel Koch, Gray Beauchamp, and David Pentecost

Kineticorp LLC

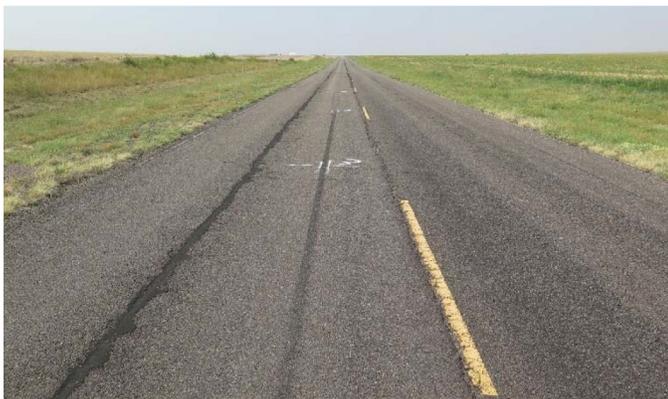
Figure 1. Photograph of Testing Roadway Taken Facing Northward.

The private roadway used for testing was a 2 lane north/south service road that is approximately 2 miles long, straight, and has minor elevation changes. [Figure 1](#) is an image of the roadway taken facing northward. The roadway consisted of asphalt that had no signs of special surface treatment. Midway through the tests series, the roadway was resurfaced. The test site was surveyed using a laser total station in one hundred foot increments and key locations were recorded with a GPS locator. The grade of the road was measured and incorporated into the final deceleration values.

In one test (8/20/15-M03), the tread belt wrapped around the axle and the wheel stopped rotating while the vehicle was at speed. This left an approximately 90 foot skid mark while the wheel was locked before the under layer was worn through and the tire rapidly lost air. This skid mark can be seen in [Figure 1](#). The tire resumed rolling after it aired out. [Figure 4](#) depicts the tread belt and vehicle at rest. [Figure 5](#) depicts the portion of under layer that was worn through.

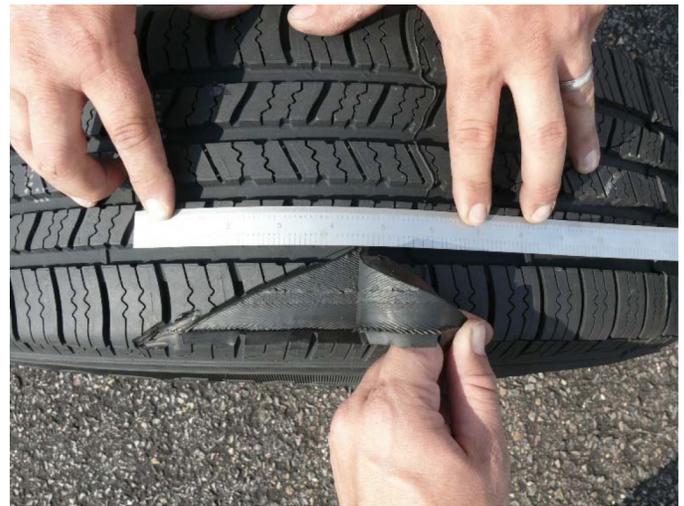
Figure 2. Photograph of a Tire Prepared for Testing.

All the tires tested were modified to produce partial or full tread belt detachments. Some tires were prepared to lose air rapidly during the tread detachment. The tires were cut along the bias of the tread and through the shoulder blocks around the circumference of the tire. The specific method of preparation was covered in detail within a previous publication [1]. [Figure 2](#) is an image of a tire prepared for testing.

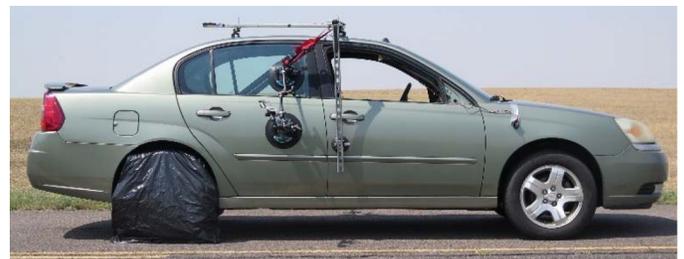
Figure 3. Photograph of the Test Vehicle Prepared for Driver Entry.

The four additional test were performed with the Chevrolet Malibu using the same methodology/location as the previous tests and span testing speeds from 58 to 69 miles per hour. Prior to the additional testing, the rear left quarter panel, which was damaged in previous testing, was repaired. All tires were prepared to produce full tread belt separations. These tests differed from the previous 25 as they were performed with the tires mounted on a side of the rear axle unknown to the driver. While the driver was absent, the tire was installed at a random location on the rear axle and covered with bags until the driver was in the vehicle. The bags were removed just before the test was conducted and the vehicle was driven down the very center of the roadway over the center lane line. In all four additional tests the vehicle's path was maintained with steering inputs less than 18 degrees.

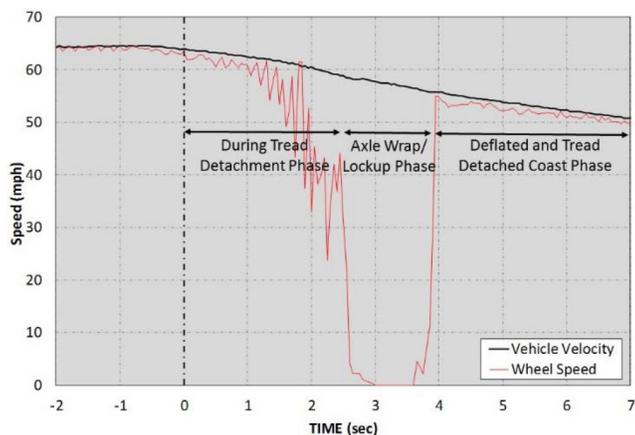
Figure 6. Plot of Wheel and Vehicle Speeds from Test 08/20/15-M03 (Full Tread Separation, Axle Wrap and Wheel Lock, Deflation).

Not all the phases occurred in every test, but each test included one or more of these phases. The [appendix](#) includes a summary of the test results and a description of which phases were included from each test. [Figure 6](#) depicts the disabled tire’s wheel speed and vehicle velocity data from Malibu test 08/20/15-M03 in which the wheel locked up. Three phases can be identified in [Figure 6](#), the During Tread Detachment Phase, Axle Wrap / Lockup phase, and the Deflated and Tread Detached Coast phase are labeled. As the disablement developed, there were small differences between the wheel speed and over the ground vehicle speed (before time zero in [Figures 6](#) and [7](#)). These differences are consistent with the noise and vibration that preceded each event. At time zero, the differences between wheel speed and over the ground vehicle speed became more pronounced as significant portions of the tire tread engaged with the vehicle. This decrease in wheel speed was identified as the start of the During Tread Detachment phase. This phase continued until the tread wrapped around the axle and the tire locked, as indicated when the wheel speed dropped to zero. The tire later deflated and began rolling again. The tire was deflated and without tread during this last phase. During the Deflated and Tread Detached Coast phase, the recorded wheel speed was slightly less than the vehicle over the ground speed. In this case, the wheel speed was generally a good indicator of the over the ground speed before the tire event and during the coast down, but underestimated the over the ground speed during the tire event.

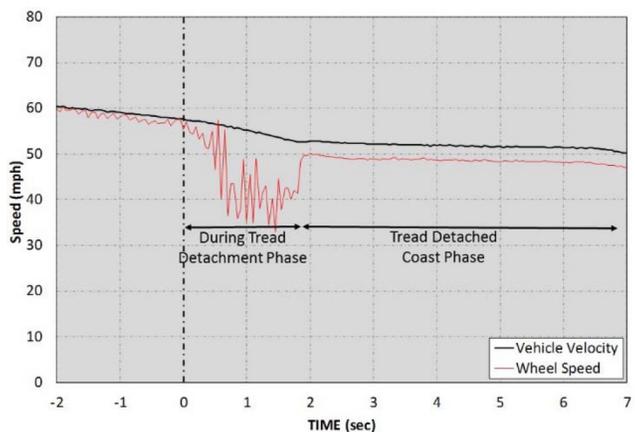
Figure 7. Plot of Wheel and Vehicle Speeds from Test 08/20/15-M02 (Full Tread Separation).

[Figure 7](#) depicts vehicle velocity and wheel speed from test 08/20/15-M02, a full tread separation test in which two phases were identified. The During Tread Detachment phase and the Tread Detached Coast phase are labeled. The tire remained inflated during this test. Small differences in wheel speed and vehicle speed are visible prior to time zero, again consistent with the noise and vibration that preceded vehicle motion. Significant portions of tread began to contact the vehicle and road at time zero, causing a drop in wheel speed. When the tread fully detached from the tire, the wheel speed became steady,

but recorded a value less than the vehicle speed. In this case, the recorded wheel speed underestimated the vehicle over the ground speed during the tread detachment and subsequent coast down.

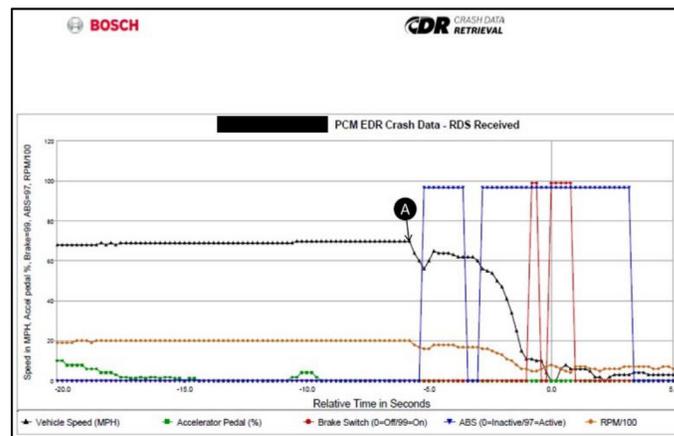
Figure 8. Plot From CDR Report in Which Vehicle Experienced a Full Tread Separation.

determine when a tire event occurred based on the vehicle speed data in the Crash Data Retrieval (CDR) report if that speed uses measured wheel speed or transmission output shaft speed. Consider Figure 8, a CDR report that captured data during a full tread separation and subsequent vehicle rollover. In this case, the vehicle was proceeding in its lane when a rear tire experienced a full tread separation. The CDR reported a steady speed of approximately 70 mph, then an abrupt speed reduction at approximately -6.0 seconds (labeled A in Figure 8) before any brake application. This reduction in reported speed is consistent with a reduction in wheel speed during the tire disablement event.

- In a real world crash, if an EDR records vehicle speed using wheel speed or transmission output shaft speed, it may be possible to identify the time of the tire event using the reported vehicle speed in the CDR report.

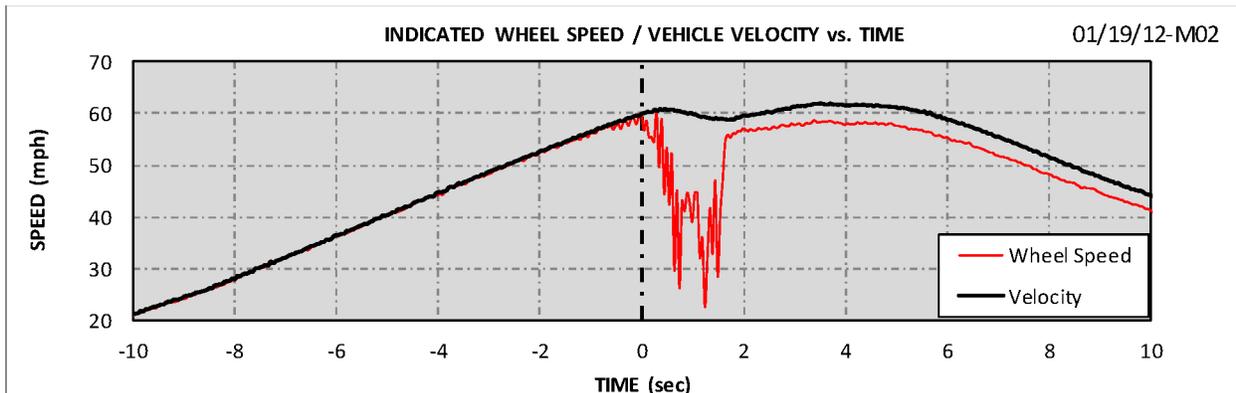
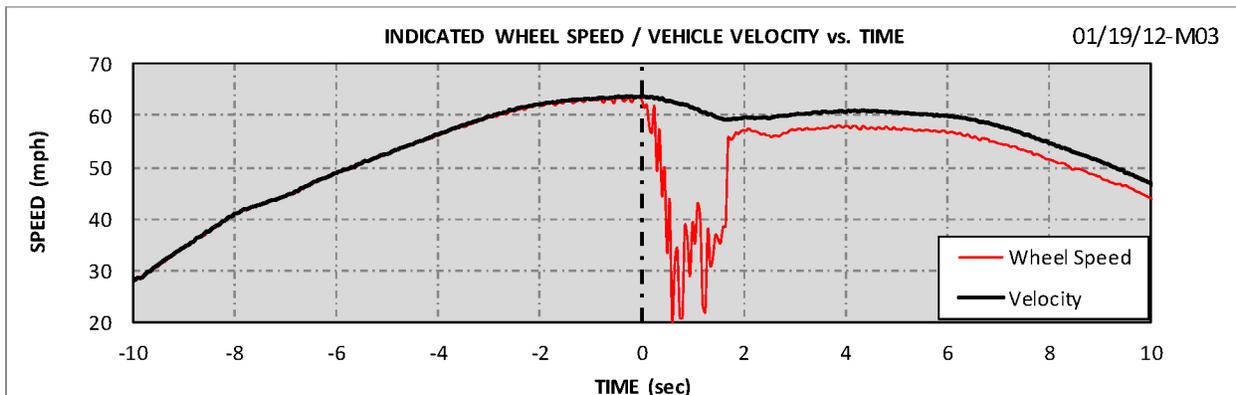
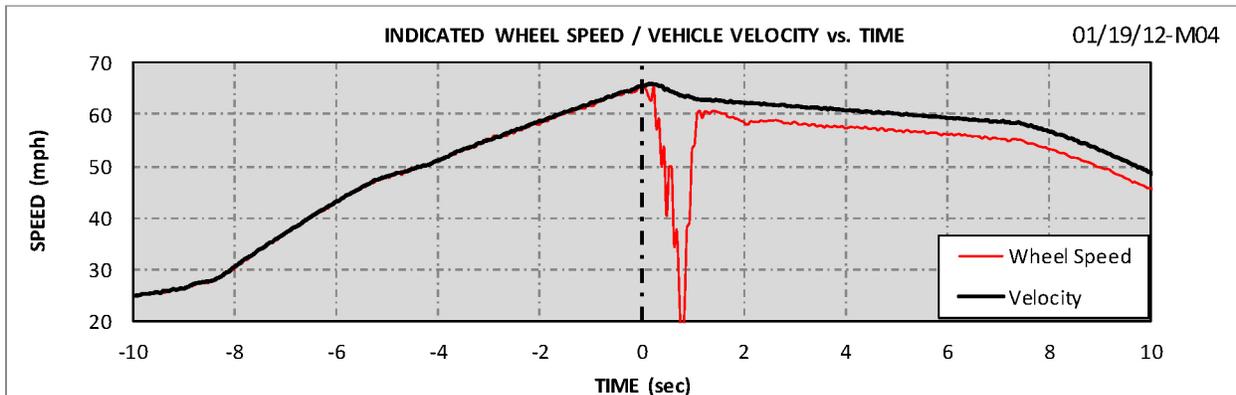
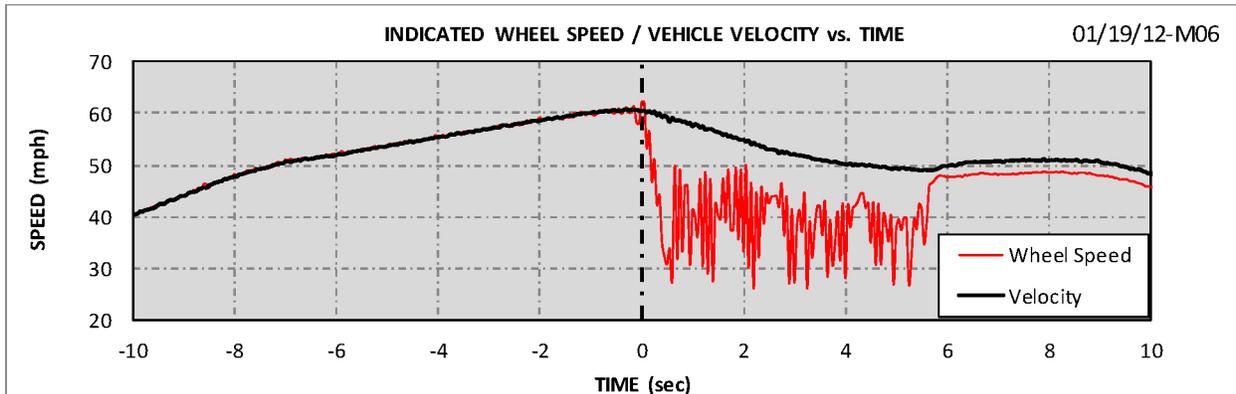
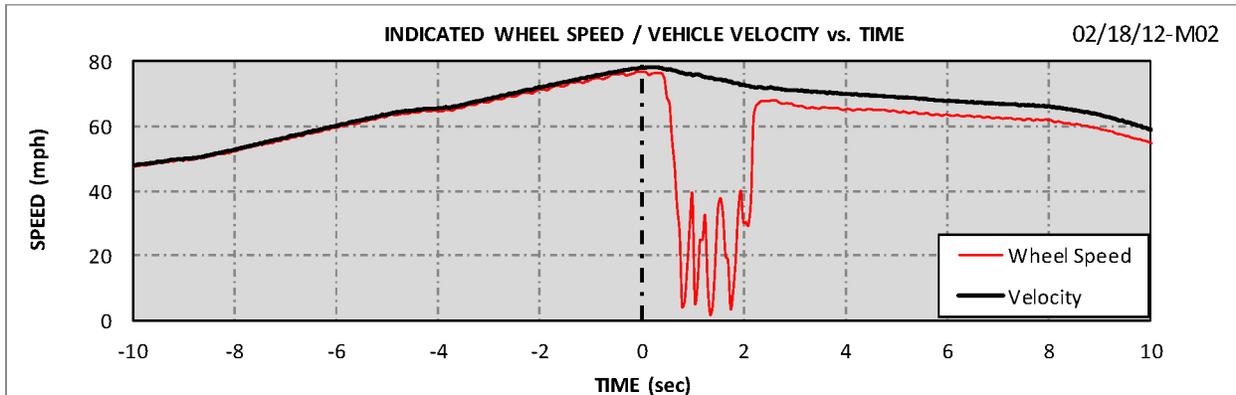
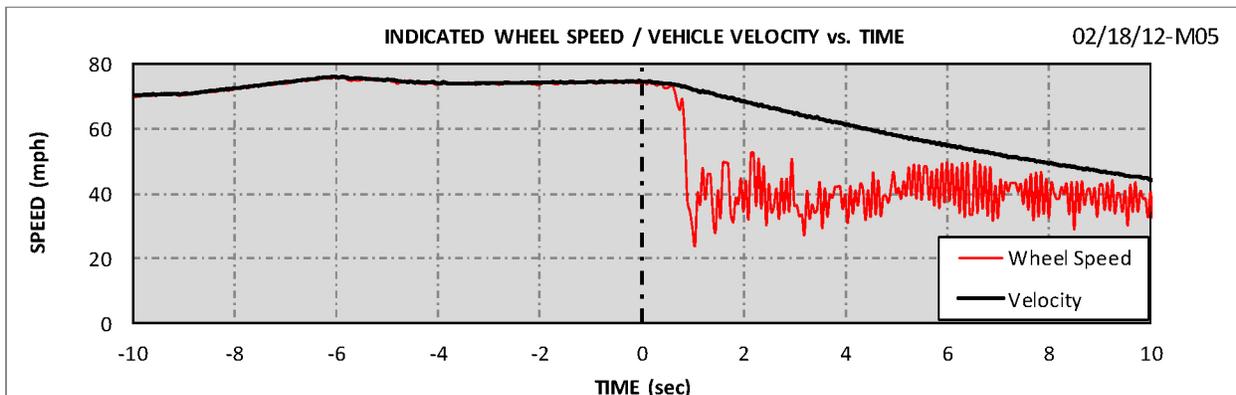
Over the ground vehicle speed and wheel speed for the disabled tire plots appear below. Wheel speeds were not measured for the Expedition tests. Wheel speed data for Minivan test 10/17/12-C01 contained interference from opposite side sensor. During minivan test 10/17/12-C04, the wheel speed sensor was damaged during the test.
