PERSPECTIVES

**Exploring Wood
Framed Roof Collapses:
Identifying Responsible
Parties & Causes of
Wood Truss Failure**

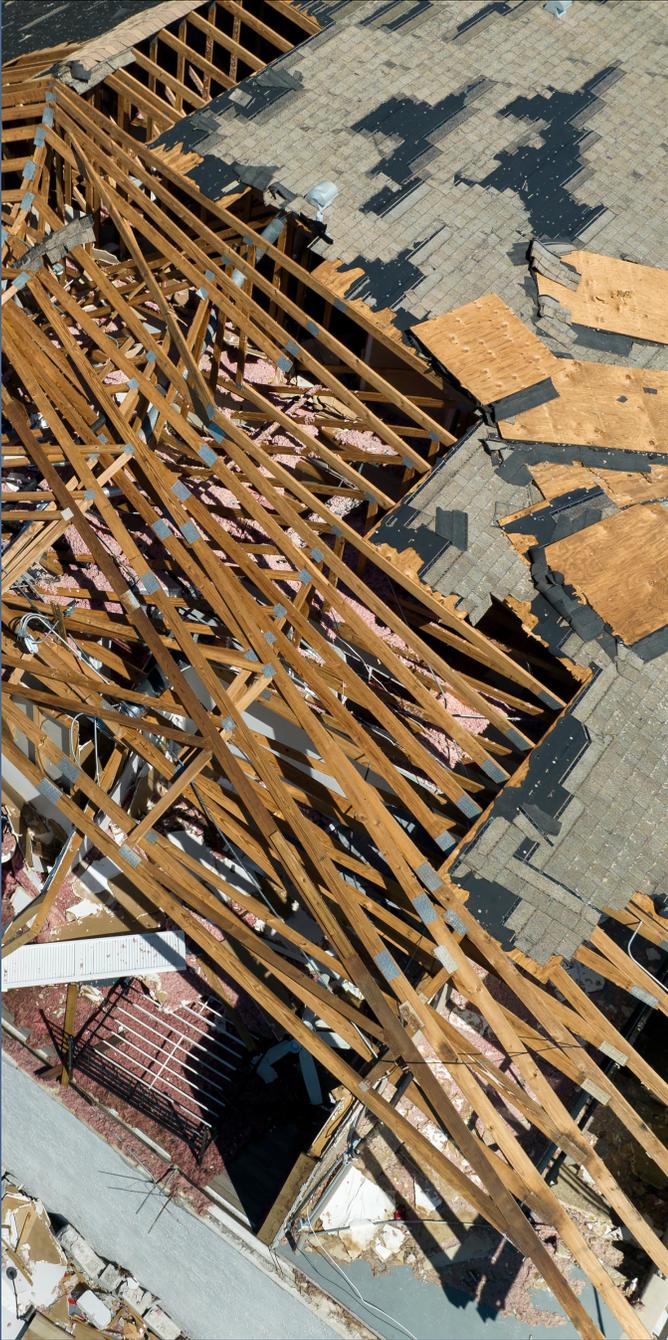
For instance, lack of communication may lead to the omission of temporary roof bracing during construction. Collapse debris of inadequately braced roofs during construction typically show trusses neatly folded over on the ground as shown in **Figure 1**.

Figure 1 - Roof collapse aftermath with neatly stacked trusses typically indicates inadequate or missing temporary roof/building bracing during erection.

The omission of temporary bracing during truss installation is a common and dangerous practice in the construction industry. The economic and life safety risks resulting from insufficient temporary bracing are typically far greater than what an erection contractor may perceive, such as complete collapse of the structure, damage to adjacent structures and equipment, and loss of life. Inadequate bracing during construction is often a primary cause of collapse in the construction industry. It is paramount that the walls and roof are adequately braced during construction or the whole structure can collapse without warning.

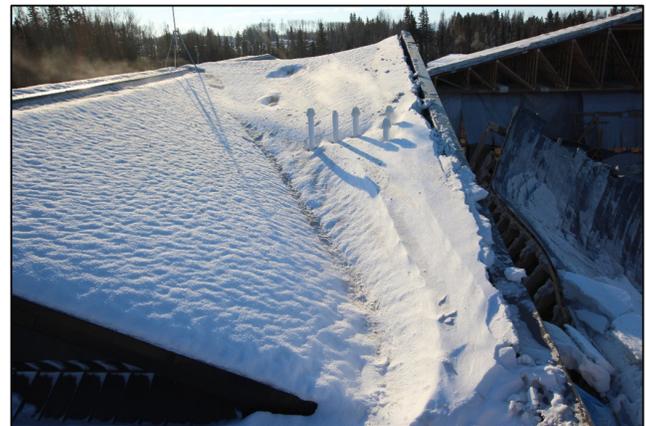
Figure 7- Example of snow accumulation in a roof valley.

on the roof is often designed to account for snow drift, it is still recommended to use a snow rake to remove large accumulations of snow. Caution should be taken when using a snow rake on the roof so that no damage is caused to the roof surface material as this inadvertent damage could also lead to premature deterioration of the trusses should the damage be severe enough to allow moisture intrusion.

As the snow continues to accumulate in the roof valley over time, and after a few freeze-thaw cycles increasing the density of the snow, the roof may eventually collapse from overloading.

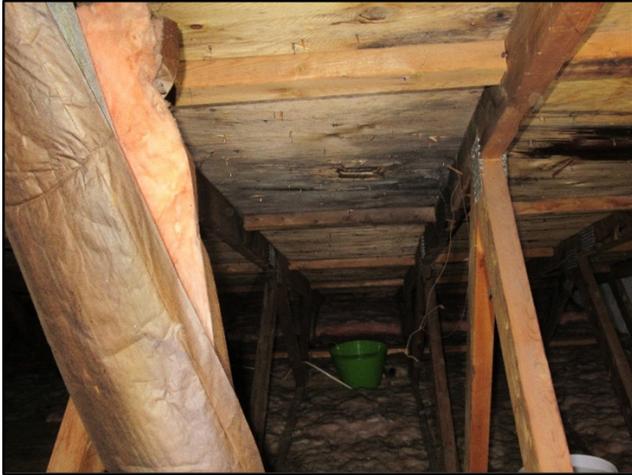
Figure 8- Decayed structural components in the attic due to poor roof waterproofing.

Installation errors in the building/roofing envelope is another common root cause of roof collapses. Deficiencies in the water management of the roofing, such as inadequate installation of the underlayment, having exposed nails on the shingles, or inadequate installation of roof flashings, etc., could promote water ingress into the attic and result in decomposition of the sheathing and trusses. As the decay continues to develop, it could negatively impact the integrity of the trusses by reducing their net capacity.

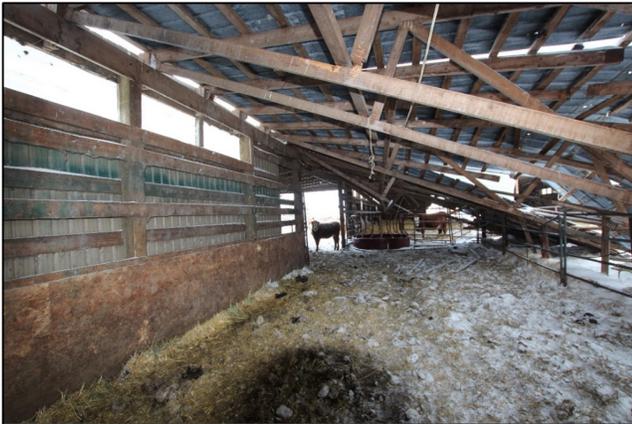
Figure 10- Example of roof collapse for a cattle barn contributed by corroded connector plates.

Corrosion of truss plates and/or nails is another of the prominent causal factors in roof collapse, and it is particularly common in agricultural and industrial buildings. While corroded truss plates could also occur in residential structures due to excessive moisture for prolonged periods in the attic, it is often not as widespread as those found in farms, agricultural, and industrial structures simply because the environments in these structures are often more corrosive and/or humid.

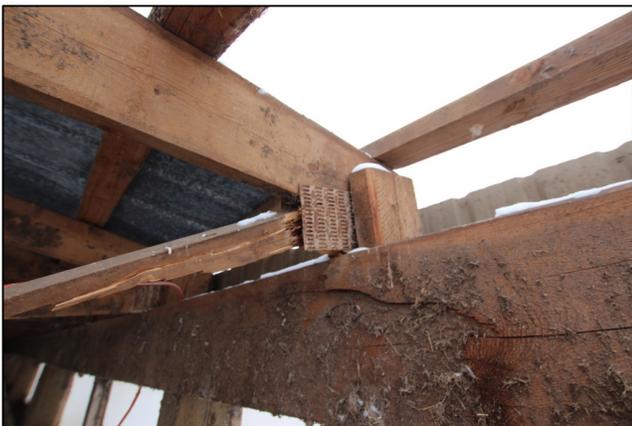
Figure 11- Example of a corroded connector plate in a collapsed roof.

standard residential/commercial grade connector plates are fabricated from sheets that are hot dip galvanized to Coating Designation G90 in accordance with ASTM A924, these plates are not adequate for service in moist, corrosive, and dusty agricultural environments where they can develop severe corrosion in fewer than 10 years.
