# PERSPECTIVES

**Exploring Wood  
Framed Roof Collapses:  
Identifying Responsible  
Parties & Causes of  
Wood Truss Failure**

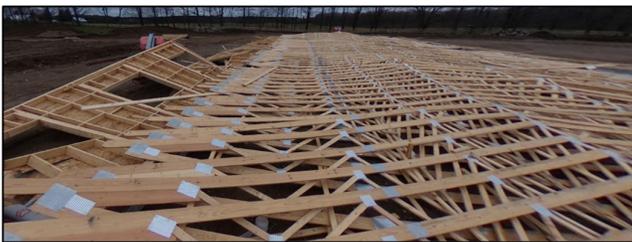
**Figure 1** - Roof collapse aftermath with neatly stacked trusses typically indicates inadequate or missing temporary roof/building bracing during erection.

For instance, lack of communication may lead to the omission of temporary roof bracing during construction. Collapse debris of inadequately braced roofs during construction typically show trusses neatly folded over on the ground as shown in **Figure 1**.

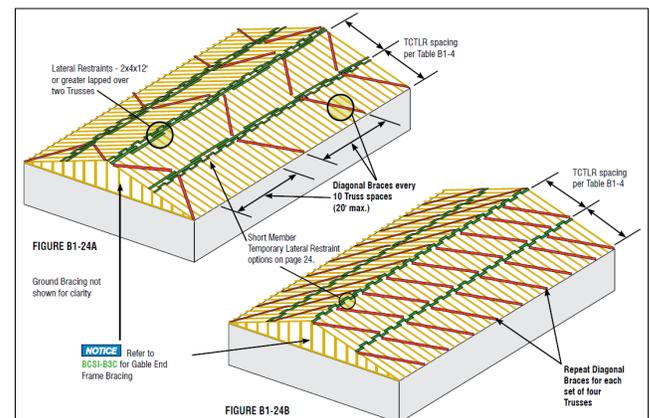
**Figure 2** - Typical temporary top chord bracing for erection (Source: BCSI Canada<sup>1</sup>)

Examples of temporary top chord bracing, permanent truss bracing, and temporary gable truss bracing are shown in **Figures 2, 3, and 4**, respectively.

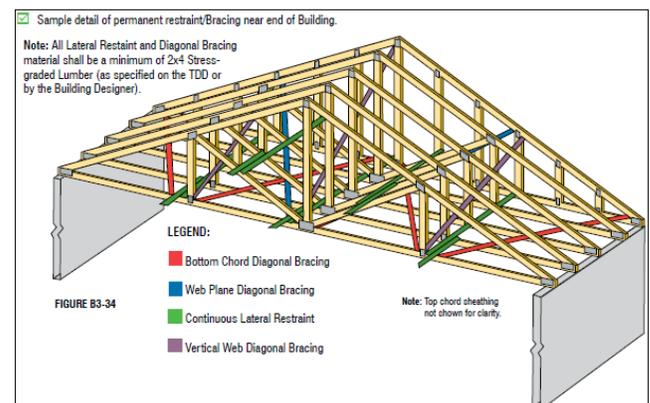
**Figure 3** - Typical permanent truss system bracing (Source: BCSI Canada).

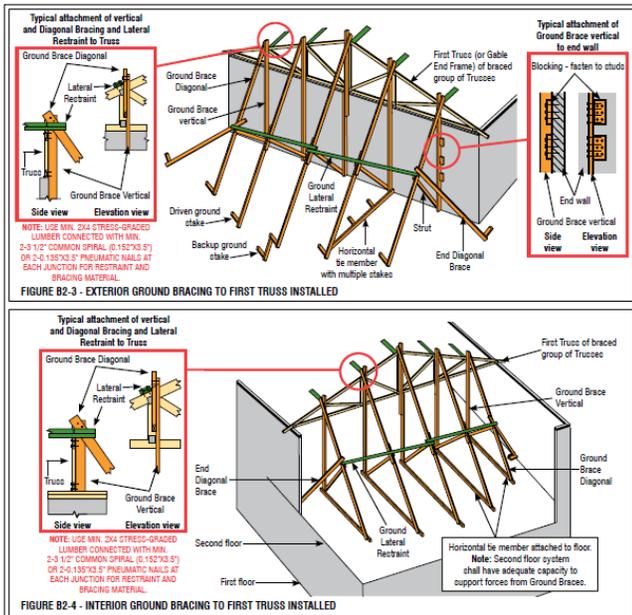
Figure 4 - Example of gable truss bracing during truss installation (Source: BCSI Canada).

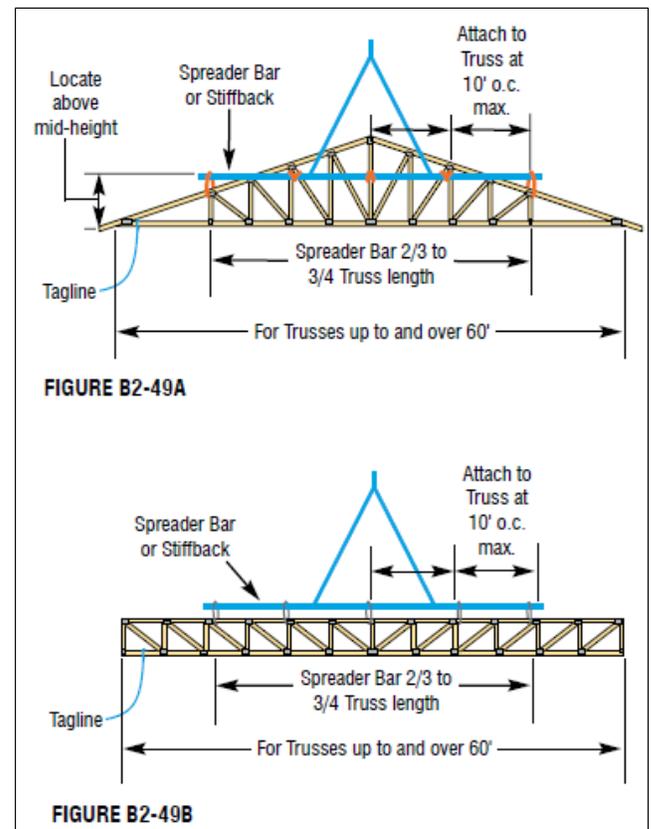
Figure 5 - Example of how spreader bars are used for truss hoisting (Source: BCSI Canada).

spreader bars as shown in Figure 5. Lifting large trusses without spreader bars could damage the trusses causing slip or deformation of the plates, sometimes in a manner not easily visible, which can significantly reduce their design capacity. In many cases, the trusses may not show signs of distress until they are fully loaded. The damage in the trusses could incubate for years before resulting in a collapse due to a heavy snowstorm which exceeds the threshold of the reduced actual capacity of the roof.

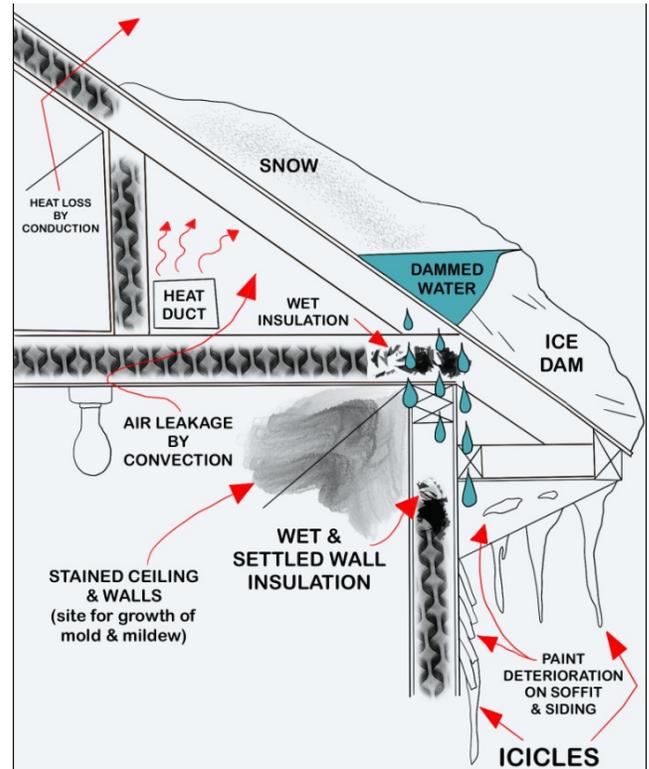
Figure 9- Schematic of ice damming (Source: <https://extension.umn.edu/protecting-home-rain-and-ice/dealing-and-preventing-ice-dams>).

Inadequate attic insulation can often be identified by the presence of ice damming along the eaves of the roof. An ice dam is formed when there is a breach of the warm air from the living space into the attic, mostly due to inadequate placement of insulation and/or vapour barrier at the bottom of the attic. The warm air that escapes into the attic would heat up the roof sheathing, melting the bottom layers of the snow above the roof. As the melted water travels near the edge, it then re-freezes near the roof edge due to the absence of heat along the roof overhang, forming an ice dam. The combined weight of ice and snow along the roof overhang that overstresses the truss heels, along with the decay of the trusses due to water damage from ongoing ice damming, could result in a localized collapse of the roof overhang.
