# Full-Scale Testing and Analysis of Tractor-Trailer Braking Performance With and Without Trailer Anti-Lock Brakes

2010-01-1891

Published  
10/05/2010Jeffrey Ball, David Danaher and Trevor Buss  
Veritech Consulting Engineering LLC

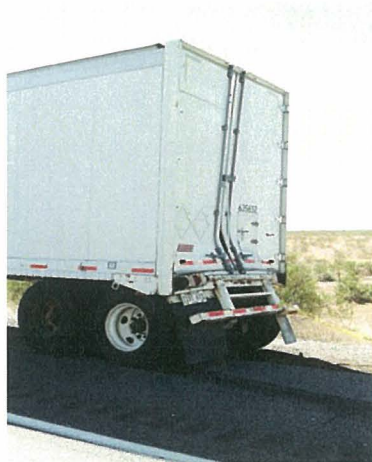
The marks left by the trailer are shown in [Figure 2](#).

Two theories were presented during the investigation. One was that the undercarriage slid aft due to the pins not being fully locked. When the undercarriage contacted the ICC bar, it dislodged from the rails. It was postulated that the marks subsequently left by the trailer were due to the rotation of the trailer bogie relative to the trailer chassis after it left the rails, and that the ABS had functioned as designed. Furthermore, the gaps in the initial tire marks ([Figure 2](#), left) were attributed to ABS cycling as opposed to wheel hop. However,

*Figure 2. Marks left on roadway by trailer.*

the undercarriage rotated clockwise when it left the rails, therefore, any dog tracking would have pulled the trailer to the right, not to the left. Furthermore, the State Police report alleged that the bogie slid aft due to impact with the stopped vehicle. Therefore, the marks deposited in [Figure 2](#) would have been made prior to any bogie displacement.

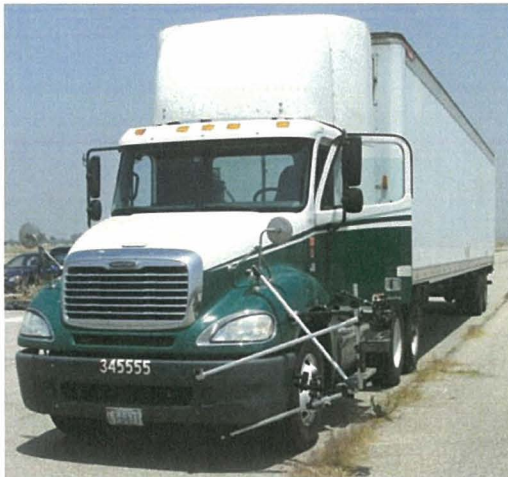
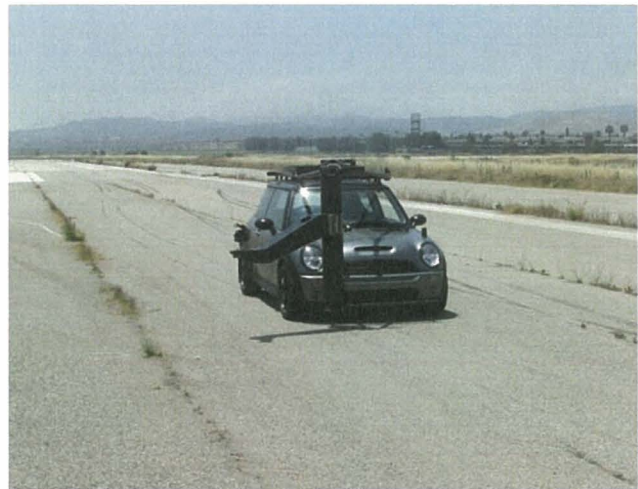
*Figure 4. Test cameras mounted on tractor and chase vehicle.*

Each test run was videotaped from a stationary camera placed at the end of the test track. Each run was also filmed by a stabilized camera mounted to a chase vehicle as well as a third camera mounted to the driver's side of the tractor facing aft. Vehicle mounted cameras are shown in [Figure 4](#).

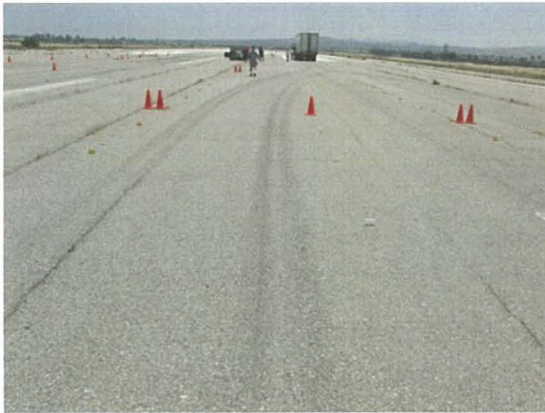
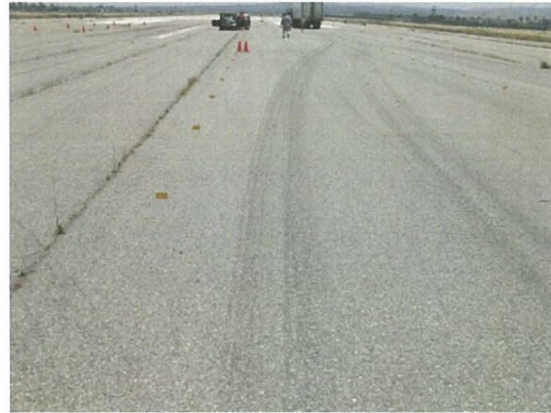
*Figure 5. Braking marks with trailer ABS on.*

the tractor was clear of the travel lane in approximately 75 feet. The first several tests were performed with the trailer ABS system activated. The resulting marks are shown in [Figure 5](#).

As shown in [Figure 5](#), the trailer with ABS deposited solid, although light, marks throughout the stop, and these marks were very similar to those deposited by the tractor, which had a functioning ABS system. Also, the marks documented at the accident scene as being deposited by the tractor were also light, "shadow" marks similar to those shown in [Figure 5](#). Therefore, these tests confirm that with a functioning ABS, a tractor-trailer will tend to deposit light skid marks throughout the stop.

During these tests, the trailer swung clockwise approximately 2-3 degrees, and had a maximum off-track (defined as the maximum lateral distance between the tractor tire marks and the trailer tire marks) of 1.5 - 2 feet. Four tests were

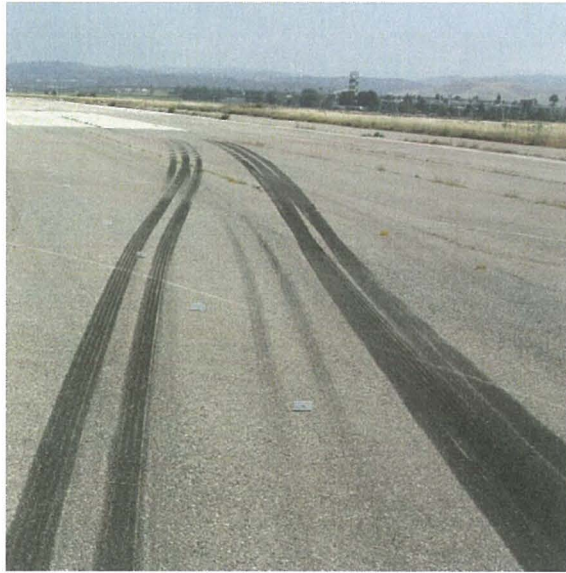
*Figure 6. Tire marks from first test with ABS disabled.*

The trailer ABS was disabled by disconnecting the plug to the module, and the braking tests were performed. On the first test with the ABS disabled, the trailer swung clockwise approximately 3-4 degrees when the swerve was initiated. However, as the driver steered left after the swerve to align with the lanes, the trailer swung counterclockwise approximately 8 degrees. In other words, as the tractor was steered left the trailer swung completely across the path of the tractor and was angled to the right of the tractor at rest. The marks from the first test are shown in [Figure 6](#).

It was noted that the left side marks (shown in [Figure 6](#)) seemed to indicate that only one set of duals on the left side of the trailer were locked. Analysis of the video taken by the chase vehicle during testing showed that the left wheels of the #4 axle failed to lock during brake application. Therefore, the one rolling set of duals provided sufficient cornering force for the trailer to track through the initial lane change with the tractor. However, once the weight shifted to the right side sets of duals, which were both locked, there were no cornering forces developed. Therefore, the trailer swung counterclockwise through the end portion of the lane change.

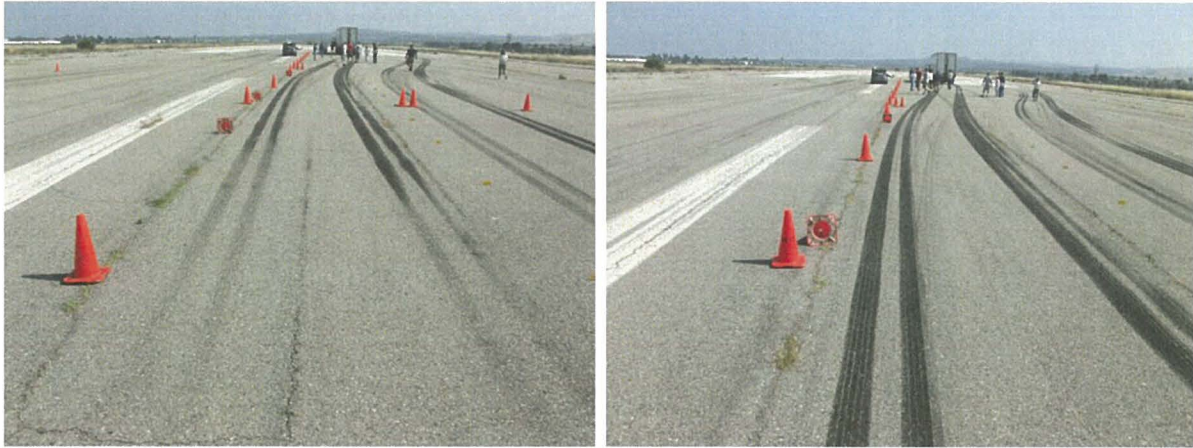
Subsequent tests with the ABS disabled produced the tire marks shown in [Figure 7](#).

As shown in [Figure 7](#), the trailer with ABS disabled deposited solid marks throughout the stop. The trailer swung clockwise approximately 12-13 degrees, and had a maximum off-track (defined as the maximum lateral distance between the tractor tire marks and the trailer tire marks) of 8.5 - 9 feet. Two tests were performed with the trailer ABS disabled, and the trailer marks measured from 274 - 296 feet.

*Figure 7. Tire marks from trailer with ABS disabled.*

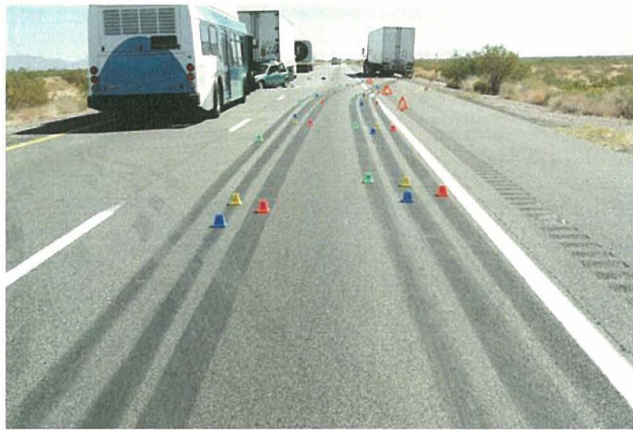
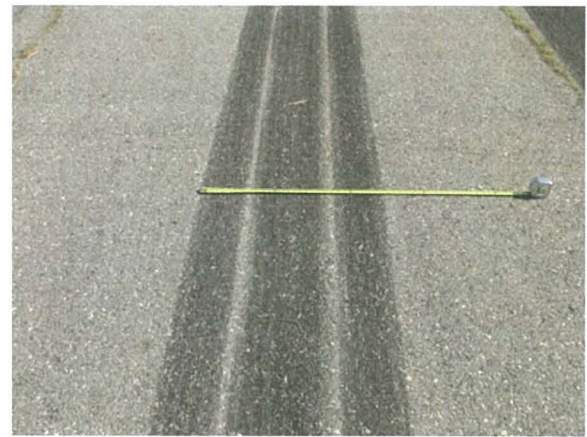
One key marker for the amount of trailer swing in the subject accident was the fact that the trailer tires started out as a set of two parallel lines, which one would expect from locked dual tires. However, at the point of maximum trailer swing, a set of three parallel tire marks were observed. This was due to the angle of trailer rotation, which placed the inside tire of axle #5 in line with the outside tire of axle #4. This phenomenon was observed during testing when the trailer ABS was disabled. The tire marks from the accident and testing are shown in [Figure 8](#).

*Figure 8. Tire marks due to trailer swing from accident (left) and testing (right).*

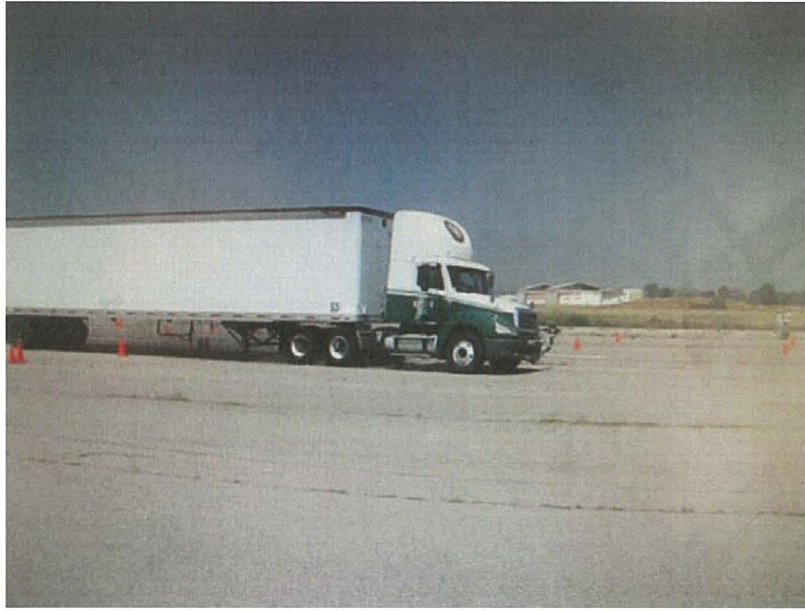
*Figure 10. Tractor wheel lift during lane change.*

error discussed above.) Analysis of the captured video showed that approximately 1 second after brake application, the tractor-trailer was established in its swerve. The video indicated that the drive wheels on the right side were slightly lifted off the ground due to the severity of the maneuver. [Figure 10](#) provides an indication of this wheel lift.

The tractor used for testing did not have limited slip differentials. The tractor had a driver-selectable differential lock, which was not selected during testing. Thus, for the purposes of the testing, the tractor had open differentials. Therefore, it is likely that the leveling/increase in velocity indicated in the ECM data was due to wheel lift during the swerve maneuver.
