# PERSPECTIVES

**Infrared Testing**  
2<sup>nd</sup> Edition

Our perspectives feature the viewpoints of our subject matter experts on current topics and emerging trends.

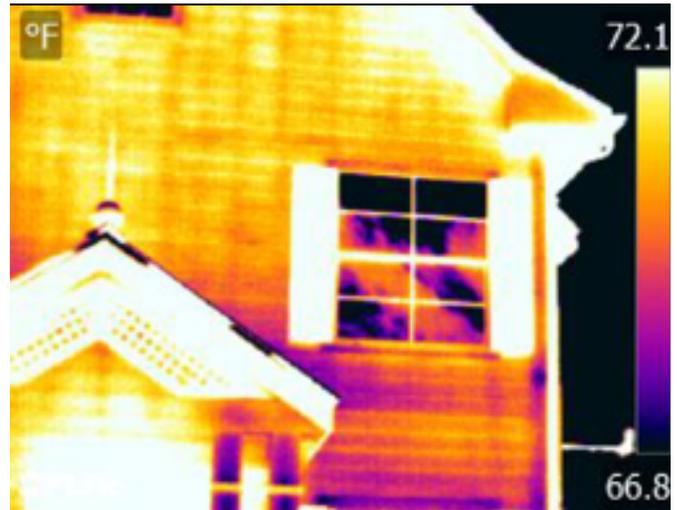
*Figure 2 - Thermal anomalies at bottom left corner of window*

The thermal pattern depicted in this single image reveals pattern anomalies at the bottom left corner of the window that could be areas of suspected water intrusion and resultant damage. However, further investigation is necessary to draw this conclusion within a reasonable degree of professional certainty. In this case, the drywall was prematurely removed from the interior face of this wall as depicted in Fig. 3 and limited deconstruction, found that the thermal anomaly was in actuality just a reflection from the adjacent metal roofing and not resultant damage from water intrusion.

This limited deconstruction could have been averted if proper methods, protocols and procedures were followed by the investigator that was improperly using the thermal image for this purpose. First and foremost, this image is taken from too far of a distance.

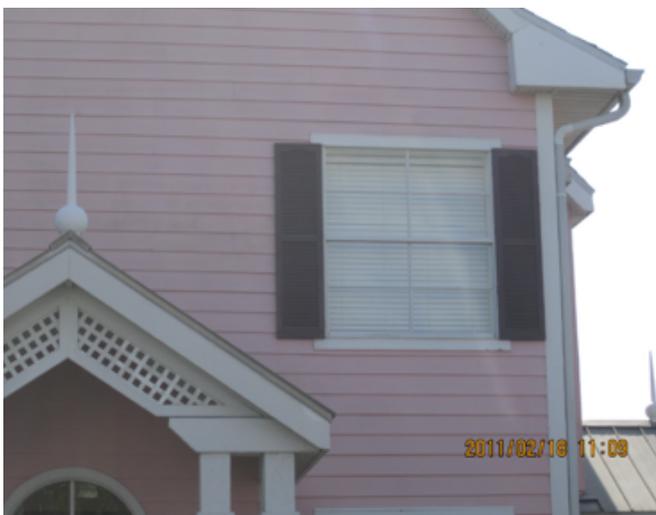
We have a documented case study that exemplifies this; Fig. 1 is a visual image of the exterior wall of a building which depicts no issues, no visual damage or discoloration of the building finishes. The initial visual image is very important and requires multiple photographs within a closer proximity for detection of moisture entrance points. Fig. 2 is the corresponding thermal image, and each visual image should have the same thermal image framed as close to the same digital image as possible, if the camera does not collect the digital and thermal image as one.

*Figure 1 - Visual image of exterior wall*

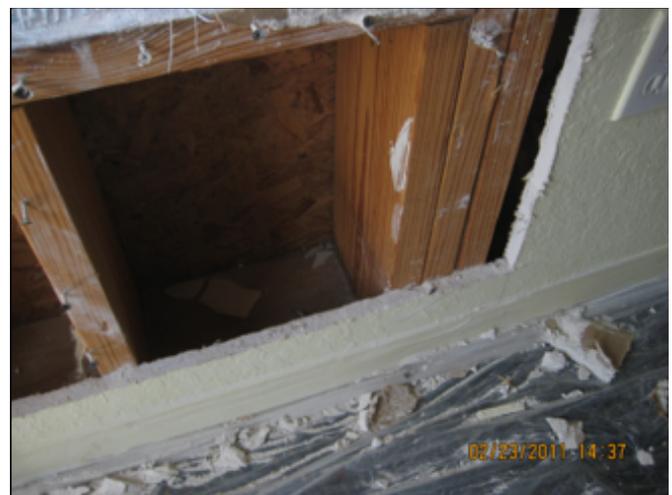
*Figure 3 - Destructive Testing performed on interior face of wall*

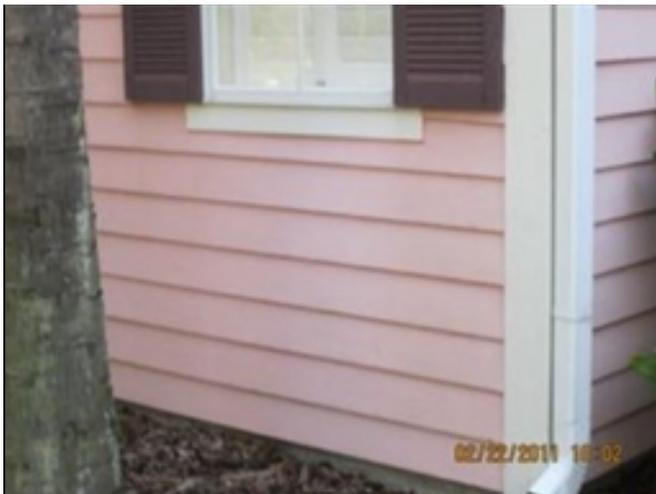
A contrasting example would be Fig. 4, which shows one visual image of the exterior wall of a building and Fig. 5, is the corresponding thermal image of the same view of the building.

*Figure 4 - Visual image of exterior wall*

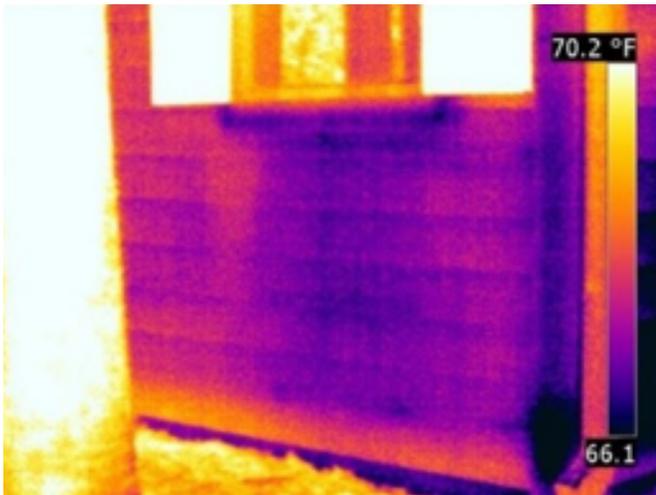
*Figure 5 - Thermal anomalies below window*

This thermal pattern also reveals anomalies located below the bottom corners of a window opening similar to the previous case. However, in this case, moisture meter readings were collected to confirm that the wood had a moisture content level above normal. Then, the exterior siding was removed from below the window opening, and Fig. 6 shows visually, the existence of water intrusion and resultant damage was confirmed. These two examples also serve to emphasize the importance of proper procedural aspects of using all investigative tools and post processing in the application of thermography.

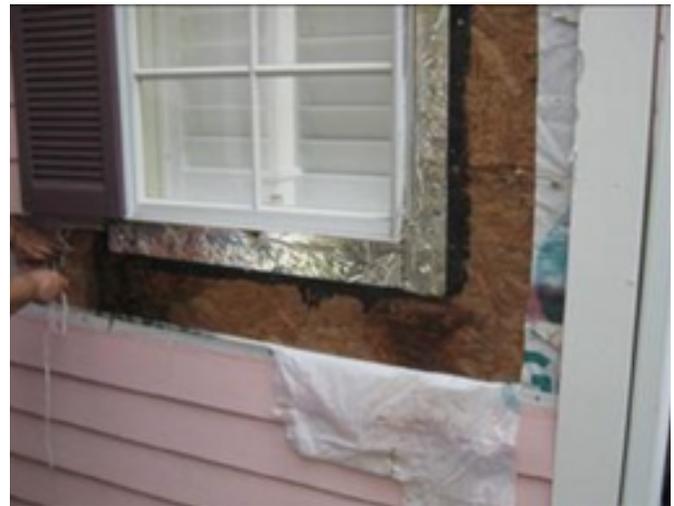
*Figure 6 - Limited deconstruction below window*

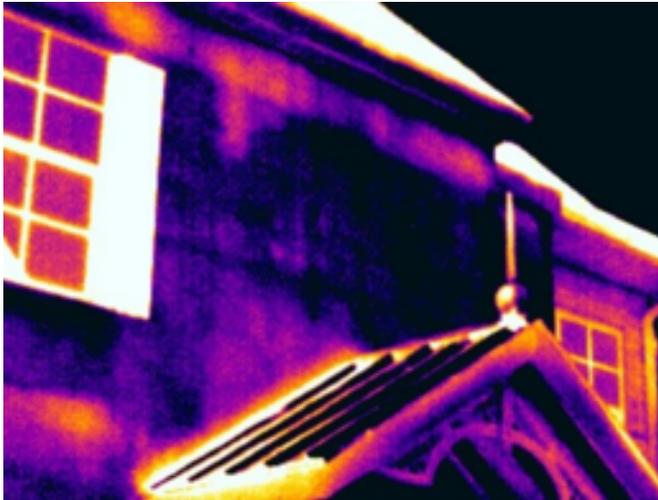
software, adjustments can be made to the temperature range or span in which the apparent temperatures are displayed. Adjusting the temperature span of a thermal image essentially adjusts the contrast, as illustrated in Figs. 7 and 8, which are the exact same image shown at different temperature spans. A short span produces a higher contrast image as depicted in Fig. 7, whereas a wide span produces a lower contrast image as depicted in Fig. 8.

**Figure 7** - High contrast thermal image with short temperature span

Thermal tuning can be abused by misrepresenting or disguising certain conditions. For example, the temperature span can be restricted to produce a higher contrast within a thermal image to intensify or exaggerate temperature differentials or anomalies. Inversely, the temperature span can be widened to reduce the contrast within a thermal image to disguise or understate temperature differentials or anomalies.

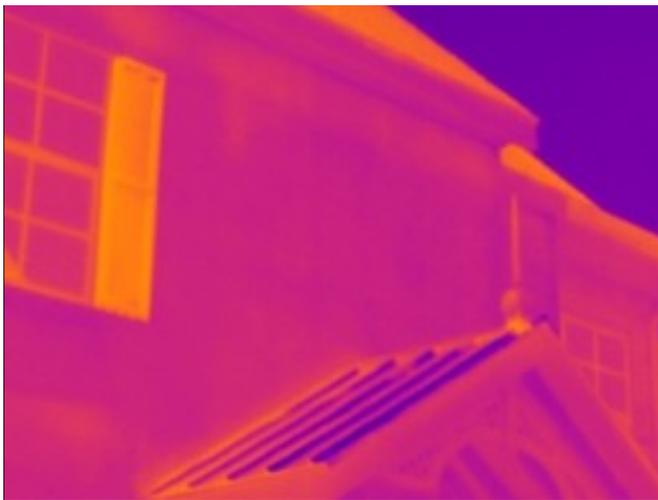
**Figure 8** - Low contrast thermal image with wide temperature span

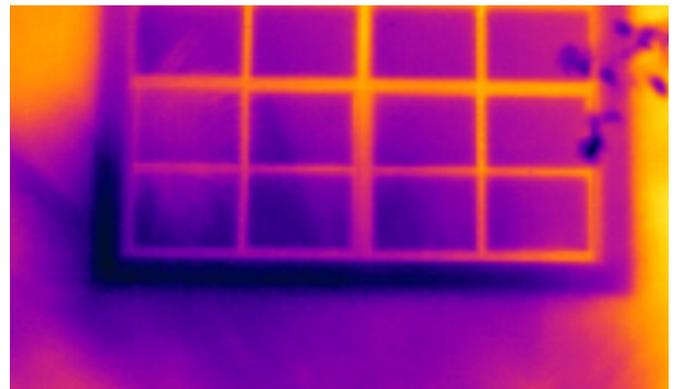
The thermal image as represented in Fig. 9 is an exterior wall of a building being inspected for possible water intrusion at the window trim. The thermal image by itself could lead an unknowing/untrained person to believe that the anomaly may in fact be damage or some type of a defect.

**Figure 9** - Unknown thermal anomaly

Without the inclusion of the corresponding digital image depicted in Fig. 10, the presence of the adjacent palm tree and its shadow would not have been presented. With this new information, it becomes clearly apparent that the anomaly was resultant of solar loading and the shadow of the palm tree.

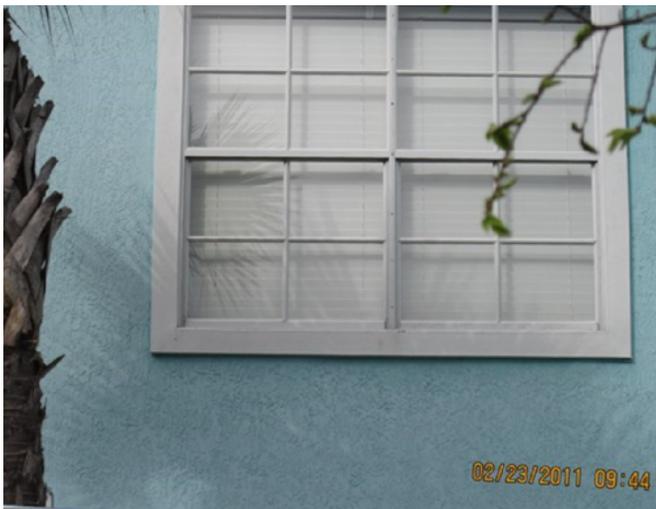
*Figure 10 - Corresponding digital image depicting shadow*
