Low Speed Override of Passenger Vehicles with Heavy Trucks

David Danaher, William Neale, Sean McDonough, and Drew Donaldson Kineticcorp LLC

Citation: Danaher, D., Neale, W., McDonough, S., and Donaldson, D., "Low Speed Override of Passenger Vehicles with Heavy Trucks," SAE Technical Paper 2019-01-0430, 2019, doi:10.4271/2019-01-0430.

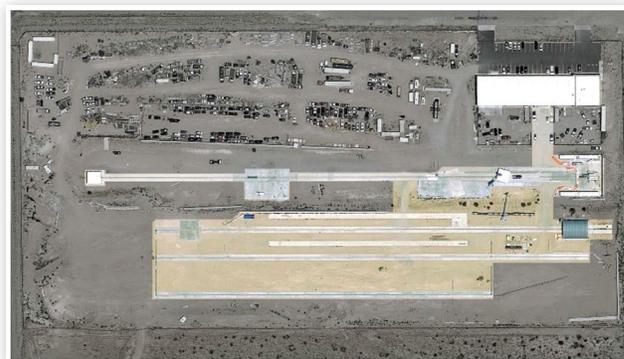
FIGURE 1 Karco Engineering Facility Aerial

Testing was performed at Karco Engineering in Adelanto, CA, which is a vehicle crash testing facility that meets NHTSA and FMVSS standards for crash testing [9]. The Karco Engineering facility includes a purpose-built crash testing track with a level concrete runway that utilizes a cable and pulley system for vehicle towing, and vehicle tracking is accomplished with a recessed monorail system. Figure 1 shows an aerial of the Karco facility with testing tracks highlighted.

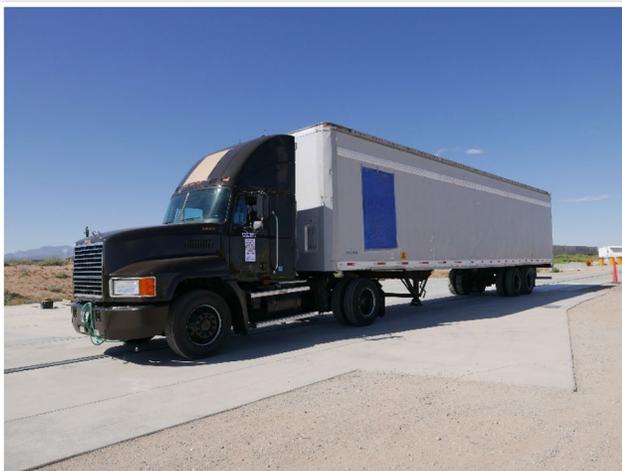
FIGURE 3 Bullet vehicle: 2001 Mack CH612 and 1998 Stoughton 45' tandem-axle trailer

Bullet Vehicle The bullet vehicle used during all rear override/underride impact tests was a 2001 Mack CH612 tractor hauling a 1998 Stoughton dry van trailer. The Mack was a 4x2 conventional day cab tractor, and the Stoughton trailer was a 45-foot tandem axle dry van trailer. The combined as-tested weight of the tractor-trailer was 28,220 pounds. [Figure 3](#) shows the bullet vehicle in as-tested configuration.

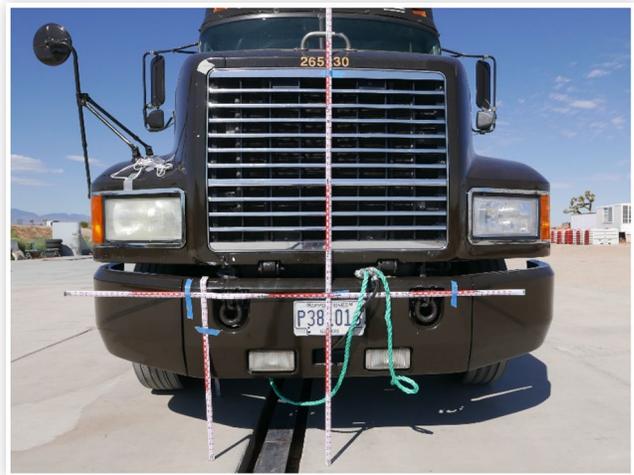
FIGURE 4 Bullet vehicle bumper cover

The front bumper of the Mack is comprised of a plastic aerodynamic bumper cover mounted to metal supports on the front of the frame rails. The plastic bumper cover is not a structural element on the front of the truck; the frame rails behind the bumper cover sit approximately 27 inches above the ground. [Figures 4](#) and [5](#) show the tractor's front bumper exterior, including height measurements from the ground.

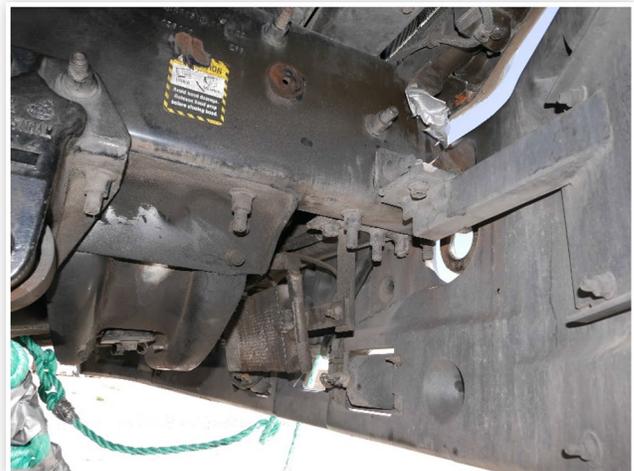
FIGURE 6 Internal view of bullet vehicle bumper and frame rails

[Figures 6](#) and [7](#) show the frame rails and metal supports behind the plastic bumper cover, including major components identification in [Figure 7](#).

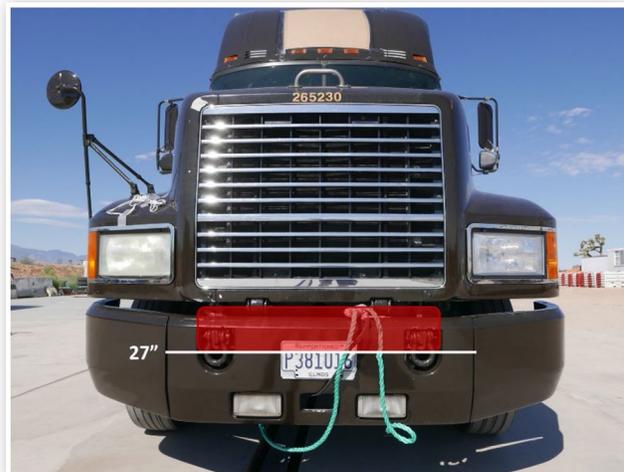
FIGURE 9 Front of bullet vehicle with metal structure highlighted

Figure 9 highlights the location of the frame rails as a reference on the outside of the plastic bumper cover. The bottom of the frame rails is approximately 27" above ground level as seen in Figure 8.

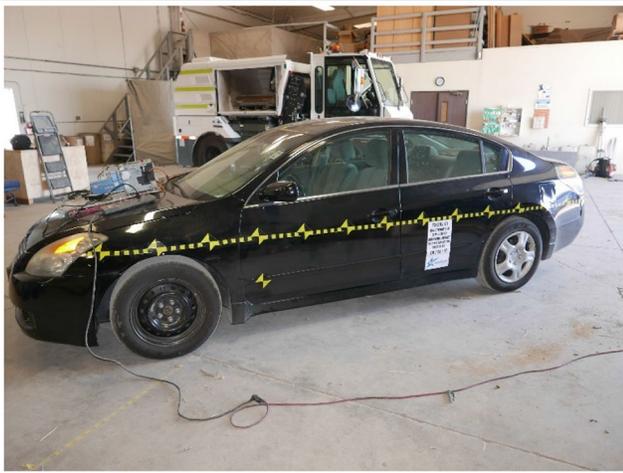
FIGURE 10 Test 1 Target Vehicle: 2008 Nissan Altima 2.5 S

Figures 10 and 11 show the Nissan prior to testing.

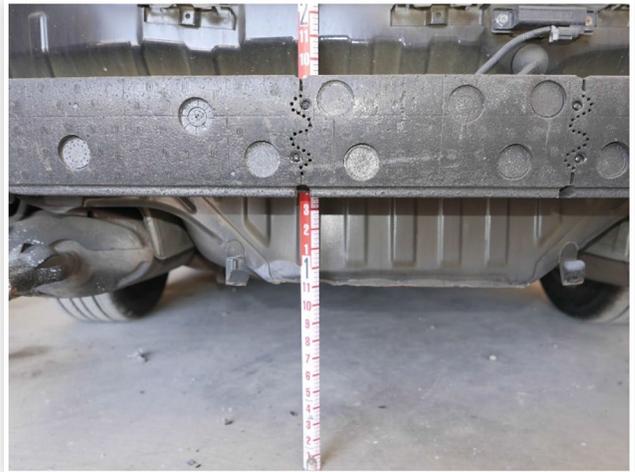
FIGURE 13 Test 1 Target Vehicle bumper beam height from ground

Measurements of the target vehicle's bumper beam structure were also taken by removing the bumper cover prior to testing. The top of the target vehicle's bumper beam was found to be 20" above ground level. Figures 12 and 13 show the bumper beam of the Nissan, including height measurements from the ground. Note that the powder covering the Nissan is laser scanner revealer spray to improve reflectivity of the black paint.

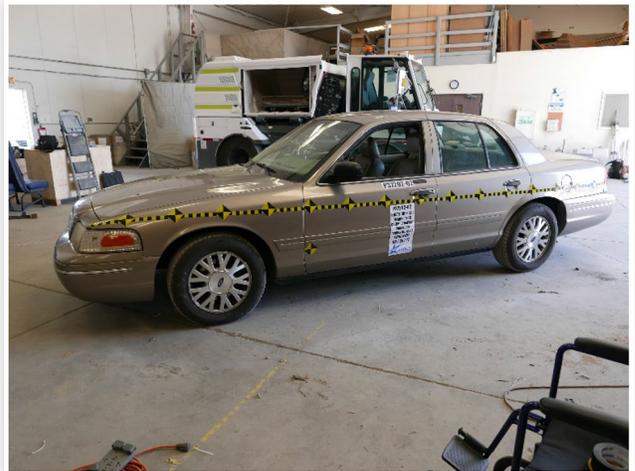
FIGURE 14 Test 2 Target Vehicle: 2004 Ford Crown Victoria LX

Figures 14 and 15 show the Ford prior to testing.

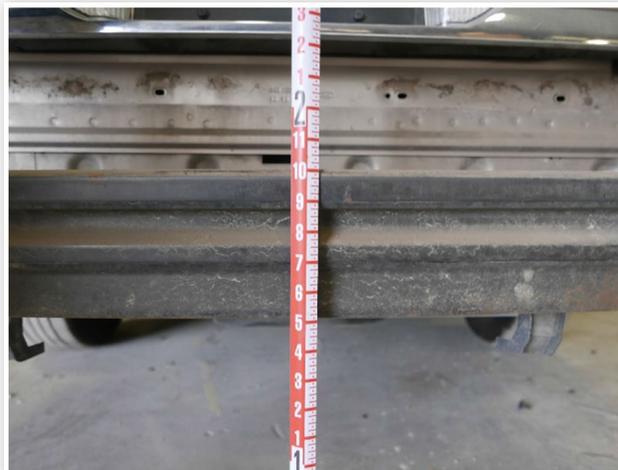
FIGURE 17 Test 2 Target Vehicle rear bumper beam height from ground

Measurements of the target vehicle's rear bumper beam structure were also taken by removing the rear bumper cover prior to testing. The top of the target vehicle's rear bumper beam was found to be 22" above ground level. [Figures 16](#) and [17](#) show the rear bumper beam of the Ford, including height measurements from the ground.

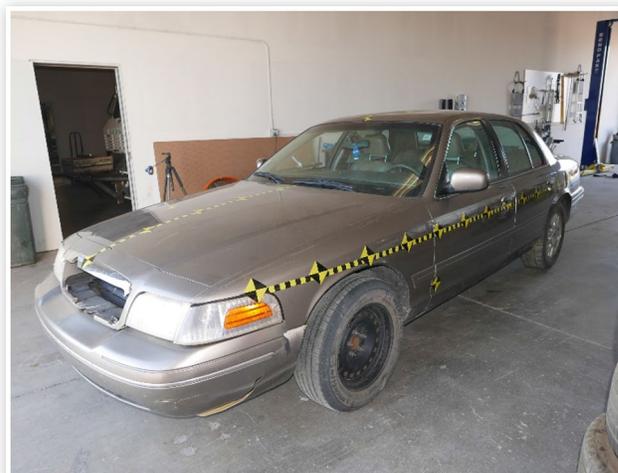
FIGURE 18 Test 3 Target Vehicle: 2003 Ford Crown Victoria LX

[Figures 18](#) and [19](#) show the Ford prior to testing.

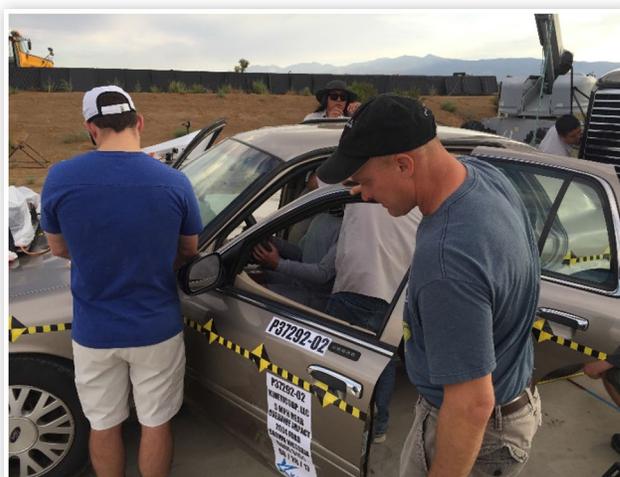
FIGURE 22 Test Vehicles Setup and Instrumentation

Figure 22 shows Test 2 vehicles being set up and instrumented on the test track.

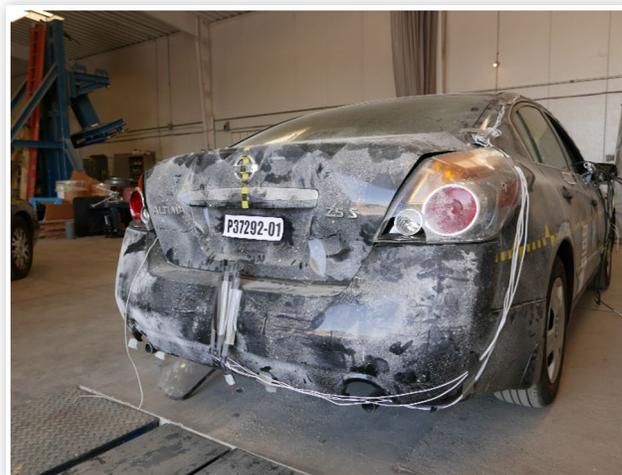
FIGURE 29 Test 1 Target Vehicle Impact Damage

Target Vehicle Impact Damage The impact to the above-bumper structures of the target vehicle resulted in damages to the trunk lid, taillights, upper bumper cover, and

the underlying sheetmetal structure of the body. [Figures 29](#) and [30](#) show overall views of the impact damage to the rear of the target vehicle.

As seen in the above post-test photographs, the trunk lid of the Nissan is dented inward in the area surrounding the license plate mount. Additionally, the passenger side taillight lens is cracked, the driver side taillight lens is no longer attached, and both taillight housings are displaced slightly outward at the leading edges. [Figures 31](#) and [32](#) show driver and passenger side views of the rear of the Nissan.

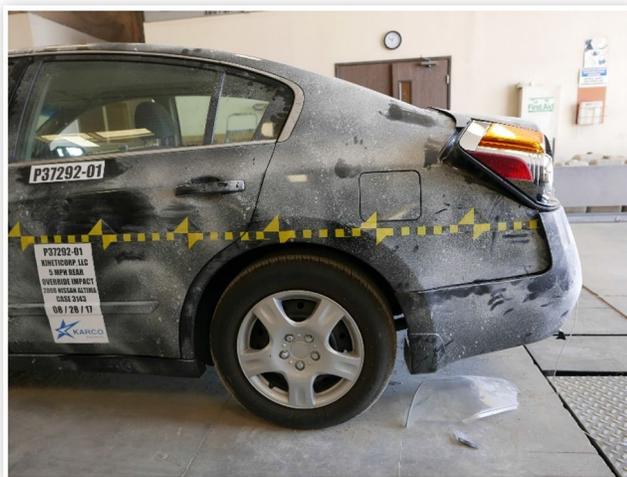
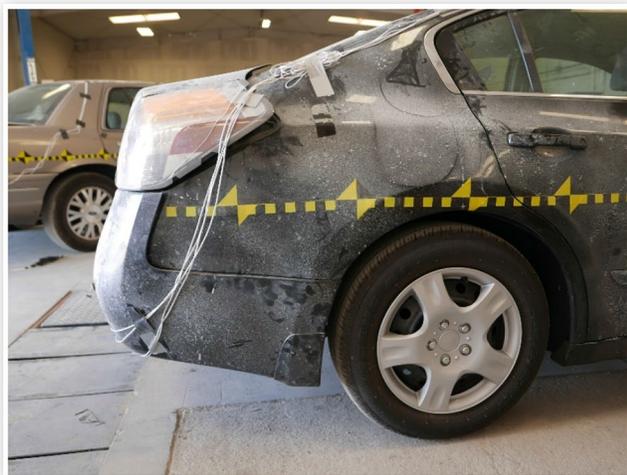
FIGURE 31 Test 1 Target Vehicle Impact Damage (Driver Side Rear)

Side perspectives better illustrate the displacement of the taillight housings outside of the quarter panels. Furthermore, these photographs show the upper edge of the trunk lid pushed forwards so that it slightly overlaps the sheetmetal, and show the bumper cover clips that detached along the leading edge where it meets the quarter panels on both sides. This deflection of the bumper cover is consistent with the minimal contact made by the bullet vehicle to the top of the bumper cover, but no contact was made to the bumper beam itself under the cover. As with the whole vehicle, the unibody experienced indirect forces as a result of the impact. However, those

indirect forces were insufficient to create permanent deformation anywhere but the trunk and body panels. [Figure 33](#) shows the rear damage to the Nissan with the scanner revealing spray partially removed for clarity.

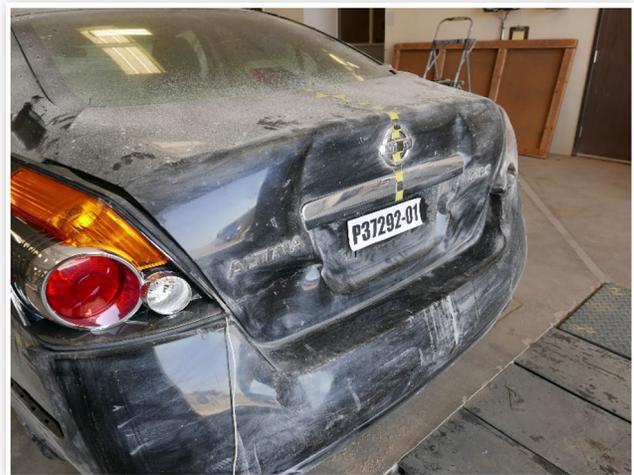
FIGURE 33 Test 1 Target Vehicle Impact Damage

This photograph more clearly shows the damaged region in the center of the trunk lid, and it also shows the minor scratches and paint cracking present on the bumper cover from the contact with the bullet tractor's front bumper cover.

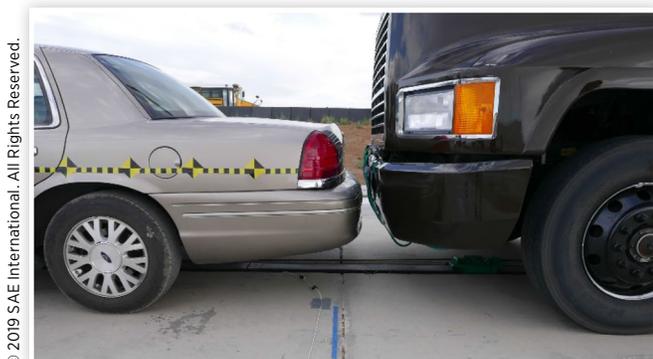
FIGURE 36 Test 2 impact alignment (side view)

Impact Alignment The bottom of the frame rails of the bullet tractor are approximately 27" above ground level, and the top of the rear bumper beam of the Ford is 22" above ground level; this height differential between frame and bumper structures creates a complete override impact to the back of the Ford. Figure 36 shows a side profile view of the bullet tractor lined up with the rear of the Ford to illustrate the frame height disparity.

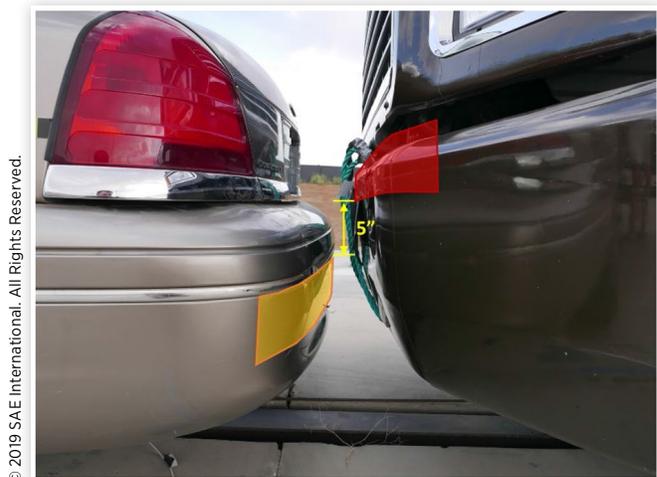
FIGURE 37 Test 2 impact alignment with structures highlighted

Figure 37 shows a closeup view of the impact alignment, with frame and bumper structure heights highlighted for clarity.

As seen in Figure 37, the bottom of the bullet tractor frame rail is approximately 5" above the top of the Ford rear bumper beam. With this impact alignment, there is no energy transferred to the frame of the target vehicle by the impact, and all energy is absorbed by the above-bumper structures.

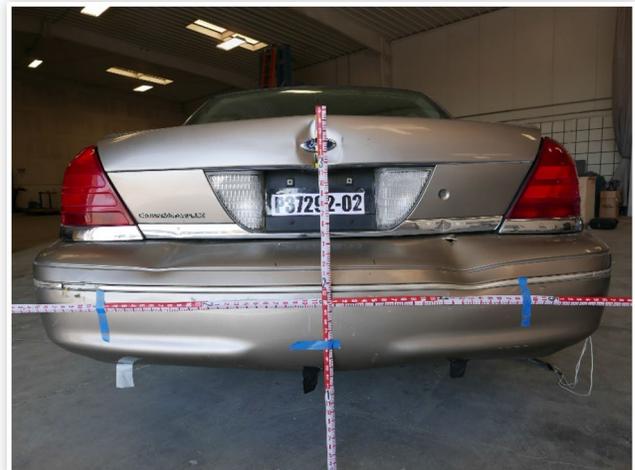
FIGURE 42 Test 2 Target Vehicle Impact Damage

Side perspectives show the bowed sheetmetal of the trunk lid, and the enlarged gap between the leading edge of the taillight housings and the rear quarter panels. Figure 42 shows a close-up view from the rear of the damage to the Ford with tape measures for scale.

This photograph more clearly shows the damaged region in the upper portion of the trunk lid, and it also shows the

minor scratches and divots present on the bumper cover from the contact with the bullet tractor's front tow hooks. These divots from the front of the bullet vehicle's frame rails are above the top of the Ford's bumper beam. As with the whole vehicle, the frame of the target vehicle experienced indirect forces as a result of the impact. However, those indirect forces were insufficient to create permanent deformation anywhere but the trunk and body panels.

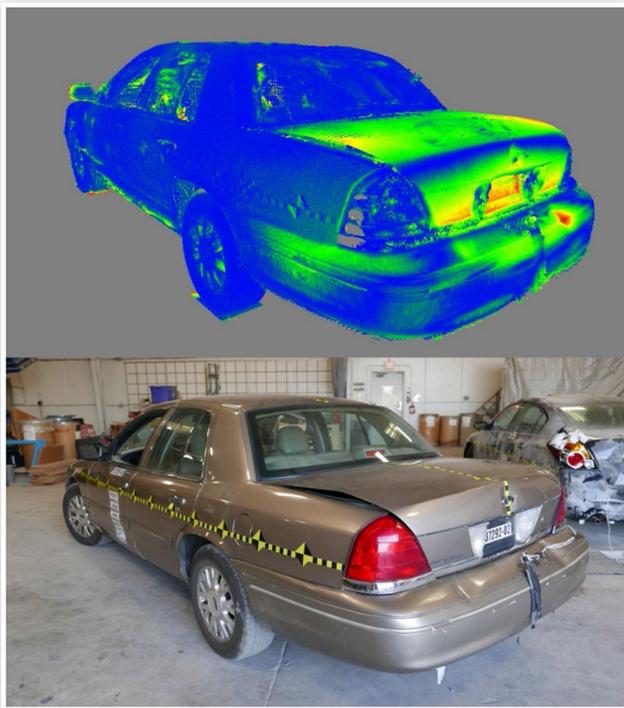
FIGURE 43 Ford Scan Data Deviation Comparison

The target vehicle was scanned with a FARO Focus 3D laser scanner before and after the impact test. Data collected by the laser scanner was processed for comparison between pre- and post-test scans of the Ford. Figure 43 shows a deviation map of the rear of the Ford, with pre- and post-test scans aligned based on the undamaged sections of the vehicle. A post-test photograph of the Ford is included for comparison purposes.

As seen in the above comparison, the maximum crush on the back of the Ford was located in the center of the trunk lid around the license plate mounting area.

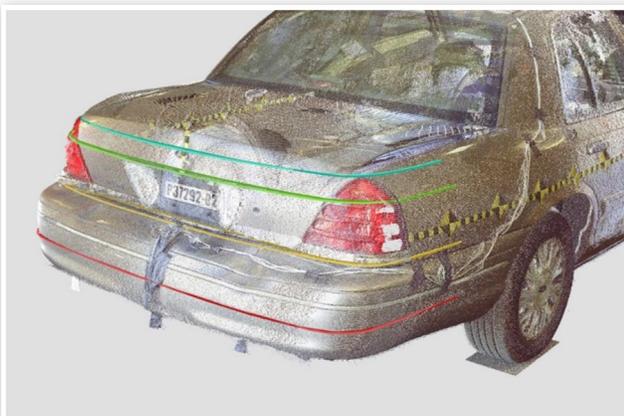
FIGURE 44 Test 2 Post-Test Scan Data with Crush Measurement Lines

Appendix A includes a summary table of crush measurements taken from the laser scan data of the pre- and post-test Ford. Crush measurements were taken at four different levels on the rear of the Ford: at bumper beam height, at the bottom edge of the trunk lid, at the trim piece above the license plate mount, and at the height of the badge on the trunk lid. The crush measurement data shows that there is very little deformation to the rear bumper cover of the Ford, with a maximum crush measurement of 0.25 inches at bumper beam height. Maximum recorded crush depth was 2.92 inches, and this crush is seen at the measurement level at the bottom edge of the trunk lid. Figure 44 shows the post-test scan data of the Ford with the pre- and post-test crush lines at each measurement level overlaid on the scans.

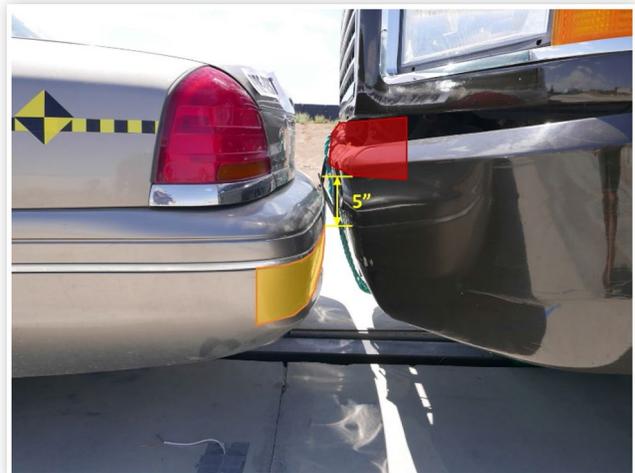
FIGURE 46 Test 3 impact alignment with structures highlighted

Figure 46 shows a closeup view of the impact alignment, with frame and bumper structure heights highlighted for clarity.

As seen in Figure 46, the bottom of the bullet tractor frame rail is approximately 5" above the top of the Ford rear bumper beam. With this impact alignment, there is no energy transferred to the frame of the target vehicle by the impact, and all energy is absorbed by the above-bumper structures.

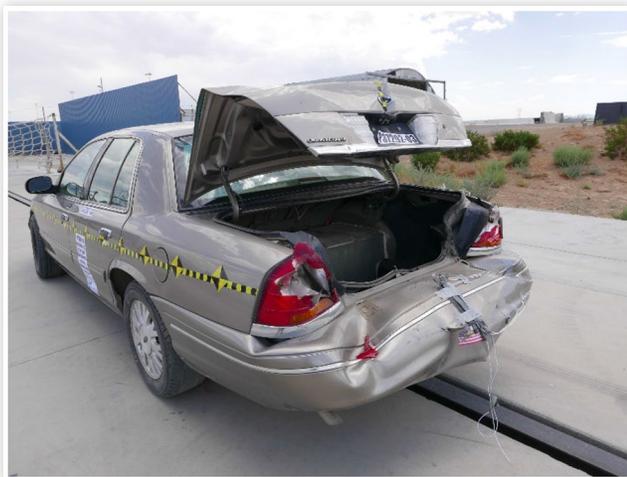
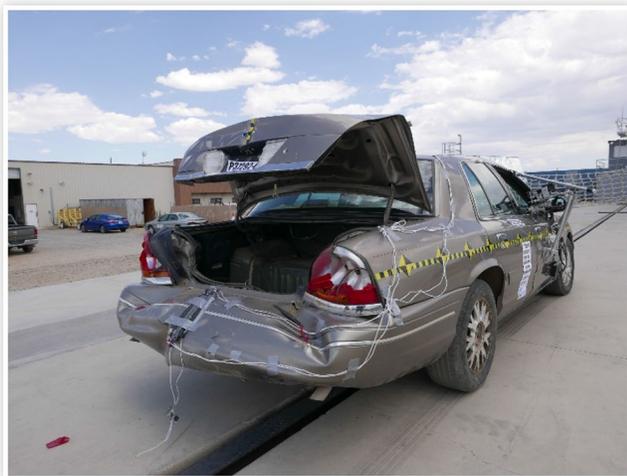
FIGURE 47 Test 3 Target Vehicle Impact Damage

Target Vehicle Impact Damage The damage imparted to the above-bumper structures of the target vehicle resulted in damages to the trunk lid, taillights, bumper cover, and the underlying sheetmetal structure of the body. [Figures 47 and 48](#) show overall views of the impact damage to the rear of the target vehicle.

As seen in the above post-test photographs, the 10 mph override/underride impact left significantly more contact damage than the 5 mph impacts. The trunk lid of the Ford is bent inward and upward, and it was bent enough to be separated from the trunk latch during impact. Additionally, the sheetmetal at the rear of the trunk opening where the latch is mounted is dented inward significantly. The taillights on both sides are cracked and displaced outward. The bumper cover is pulled upwards and inwards at the upper edge where it

meets the bottom of the trunk lid. The damage to the bumper cover is from the bullet vehicle's front end pushing the upper portion of the cover over the top of the bumper beam, and it is not indicative of direct contact with the Ford's bumper beam. As with the whole vehicle, the frame of the target vehicle experienced indirect forces as a result of the impact. However, those indirect forces were insufficient to create permanent deformation anywhere but the trunk and body panels. [Figures 49 and 50](#) show driver and passenger side views of the rear of the Ford.

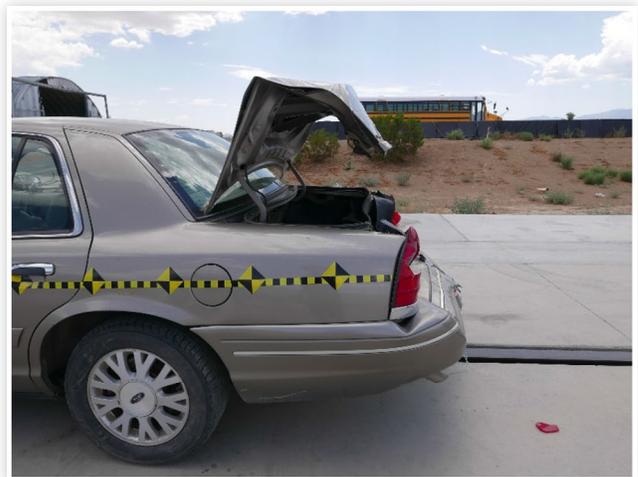
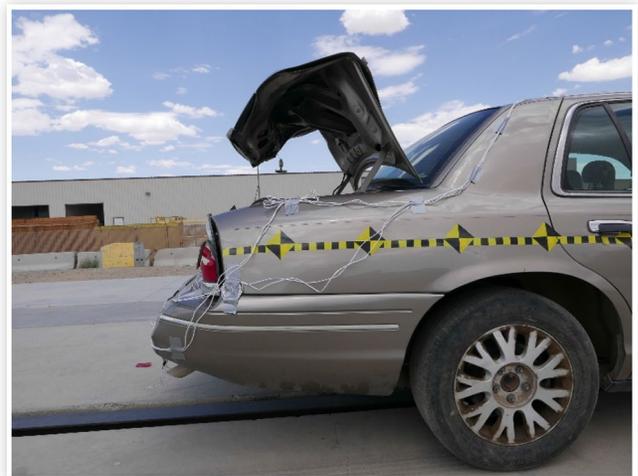
FIGURE 49 Test 3 Target Vehicle Impact Damage (Driver Side Rear)

Side perspectives show the bent and displaced trunk lid, the crushed taillights, and the deformed upper portion of the bumper cover. [Figure 51](#) shows a close-up view from the rear of the damage to the Ford.

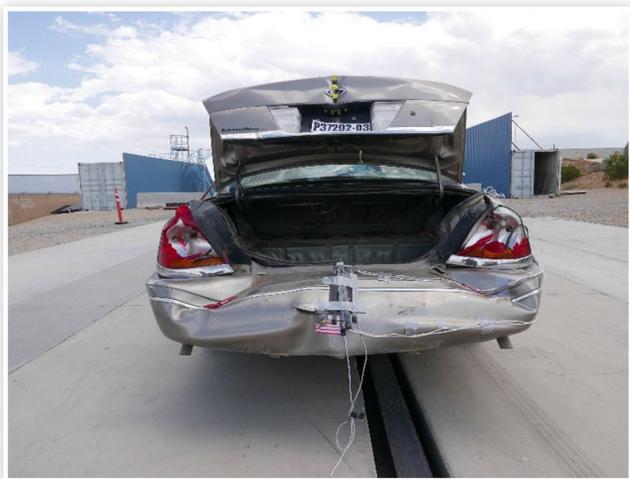
FIGURE 51 Test 3 Target Vehicle Impact Damage

This photograph more clearly shows the damage profile of the rear of the Ford from the 10 mph impact. The damage is concentrated in the center of the rear end of the Ford, around the area where the license plate is mounted in the trunk lid. The

crush depth tapers down toward the sides of the vehicle as seen in the final position of the cracked taillights, which is consistent with the shape of the front end of the bullet vehicle.

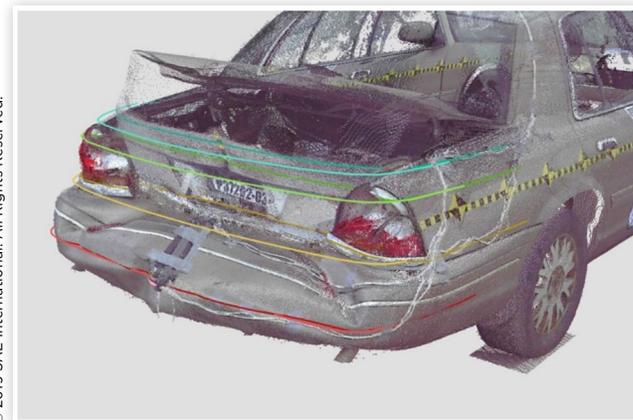
FIGURE 53 Test 3 Post-Test Scan Data with Crush Measurement Lines

Appendix A includes a summary table of crush measurements taken from the laser scan data of the pre- and post-test Ford. Crush measurements were taken at four different levels on the rear of the Ford: at bumper beam height, at the bottom edge of the trunk lid, at the trim piece above the license plate mount, and at the height of the badge on the trunk lid. The bumper cover of the Ford did experience some deformation during the 10 mph impact test as seen in the crush measurements, but the bumper beam underneath the cover did not absorb any impact energy. Maximum recorded crush depth on the Ford was 10.87 inches, and this crush is seen at the measurement level at the bottom edge of the trunk lid. [Figure 53](#) shows the post-test scan data of the Ford with the pre- and post-test crush lines at each measurement level overlaid on the scans.
