JS|HELD

WHITE PAPERS &  
RESEARCH REPORTS

## Fourier-Transform Infrared (FTIR) Technology & Analysis

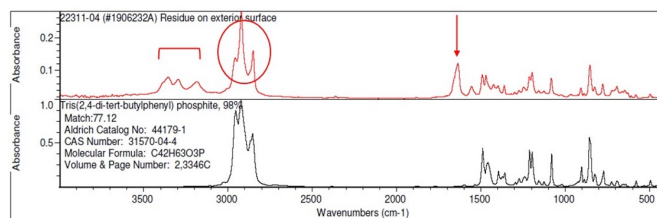
A small fragment (5/1000 inch) of the lighter colored contaminant, shown in the microscope view in Figure 3, was analyzed by FTIR and identified as containing phenyl phosphite (Figure 4), an anti-oxidant commonly used in processing of polyethylene (PE) to prevent thermal degradation at high temperatures. The FTIR spectra also contained extra peaks not associated with the antioxidant as shown by the red markings in Figure 4.

**Figure 4** - FTIR spectra of contaminant #1 compared to a phenyl phosphite anti-oxidant.

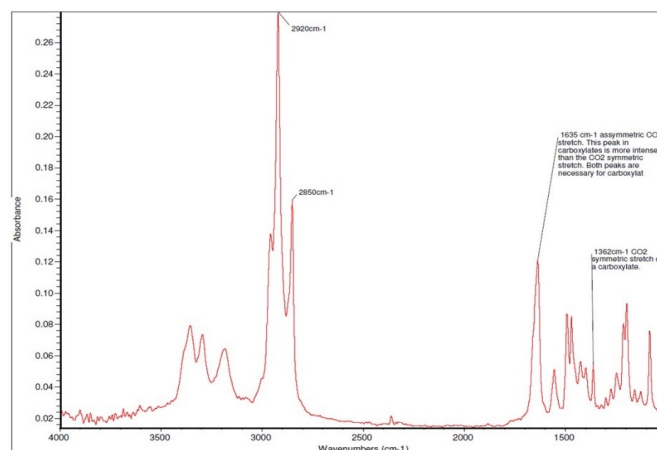
Figure 5 shows the result of spectral subtraction performed on the spectra to remove or “subtract” the phenyl phosphite peaks and reveal the masked or hidden substance(s). Peaks in the “fingerprint” region show strong evidence of a carboxylate such as a stearate. Stearates are wax-like or soap-like substance derived from fatty acids in vegetable oils or fats such as coconut and palm oils. Carboxylates can be identified by their characteristic peaks at wavenumber 1635 cm-1 and 1362 cm-1 with the former relatively more intense than the latter as evident in the FTIR spectra in Figure 5.

**Figure 5** - Resulting spectra after subtraction of phenyl phosphite.

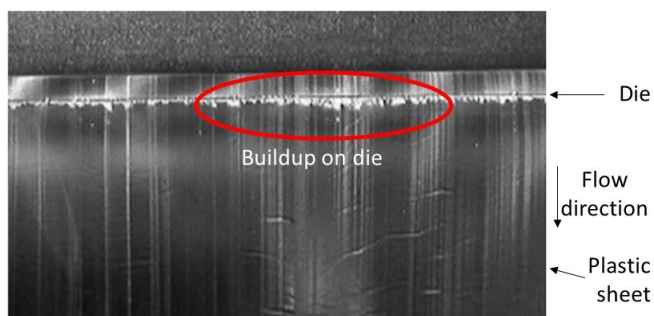
erucamide will “bloom” lightly to the surface but the concentrations will be so low as to not be visible. However, when excessive amounts of processing aids such as lubricants and slip compounds are used and/or a higher density resin is used than was intended, (e.g., HDPE instead of LDPE), the additives can form deposits on surfaces of molds, dies, or other processing equipment and later slough off on to the plastic during production. The phenomenon is known as “plate-out” or “die drool.” Figure 6 shows an extreme example of the buildup on the die of a plastic sheet extrusion machinery die. It was concluded that erucamide/anti-oxidant plate-out residue had accumulated on the die and deposited on the thin sheets that were later thermoformed into the baby bottle liners.

**Figure 6** - Molten polyethylene is pushed through a metal die to form thin sheets for later thermoforming of liners. Plate-out or “die drool” seen here is the buildup of additives on the die and can later sluff off onto the plastic.

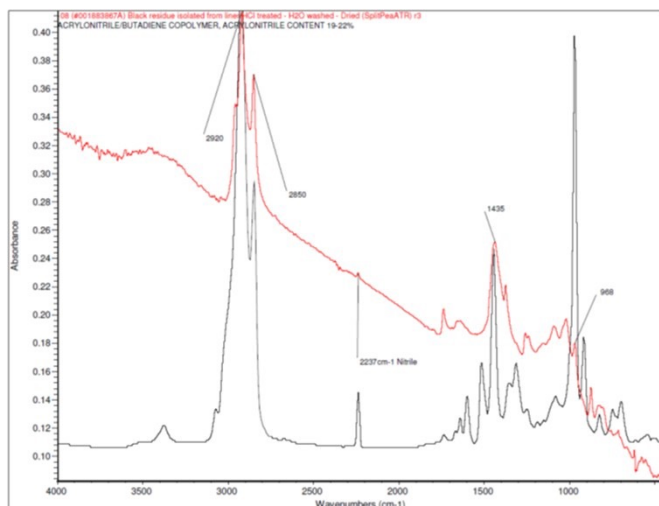
Figure 9 is the FTIR spectra of the cleaned rubber particle and the spectra of Buna-N rubber showing an excellent match. Calcium carbonate filled Buna-N rubber is commonly used for rubber O-rings, washers, and gaskets. The contaminants were traced back to manufacturing equipment. The O-rings were found to have been deteriorating, resulting in small particles breaking off into the molten polyethylene and becoming embedded in the liners.

**Figure 9** - FTIR scan of cleaned black rubber particle sans calcium carbonate filler compared to acrylonitrile butadiene rubber or Buna-N.

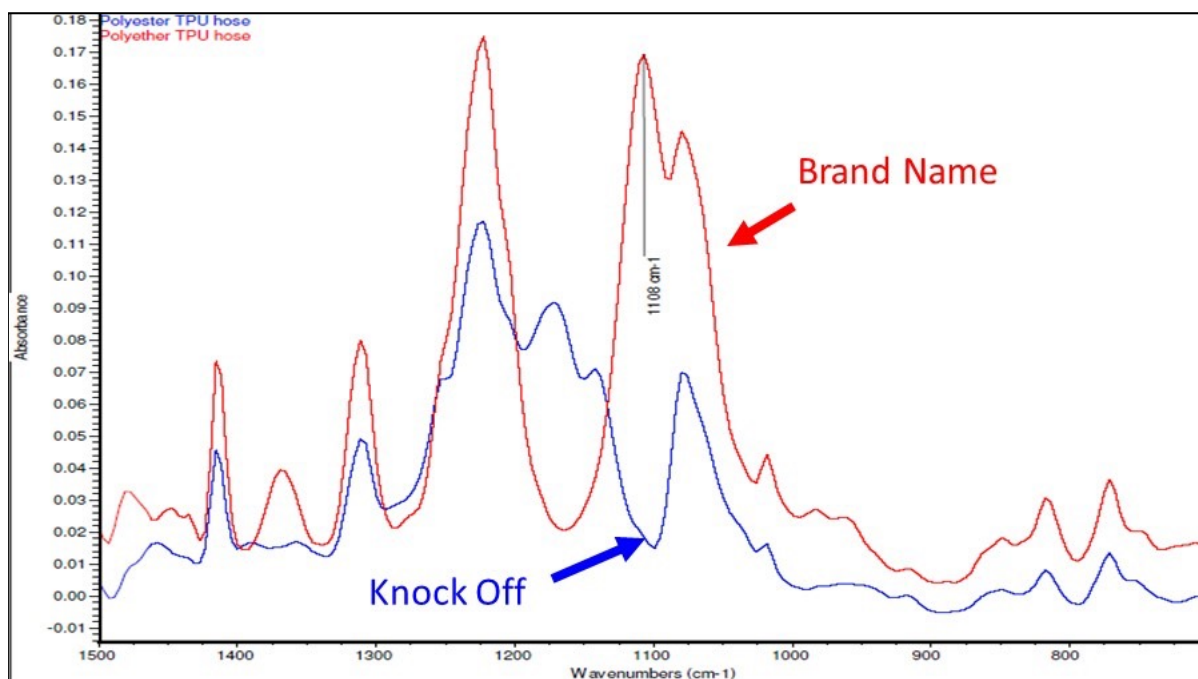
**Figure 13** - FTIR spectra of knock off and brand name TPU hoses. Note the presence of the ether peak at 1108 cm-1 for the brand name hose and its absence in the knock off hose.

The presence of this peak indicated that the brand name TPU contained a chemical bond called an “ether” linkage, and the lack of such a peak in the failed and knock-off TPUs indicated an “ester” linkage connecting the polyurethane portions of the molecule.

This distinction is important because TPUs with ester linkages (polyester TPU) are known to be susceptible to hydrolytic degradation while TPU with ether linkages (polyether TPU) are much more resilient to this type of decay. Testing and analysis showed that the combination of moisture in contact with the rubber hoses, the higher temperatures found in tropical environments, and, critically, the use of polyester (versus polyether) type TPU material for the hoses caused the rapid deterioration and failure of the scuba air hoses. Even though both air tubes were made from TPU, the specific polymer chemistry chosen to make the failed tubes was inappropriate for the application, being highly susceptible to environmental degradation and potentially leading to clogging of the second stage regulator of a scuba diver, in turn leading to loss of air supply. Consequently, the Consumer Products Safety Commission (CPSC) was notified, and corrective measures have been taken to address the issue.

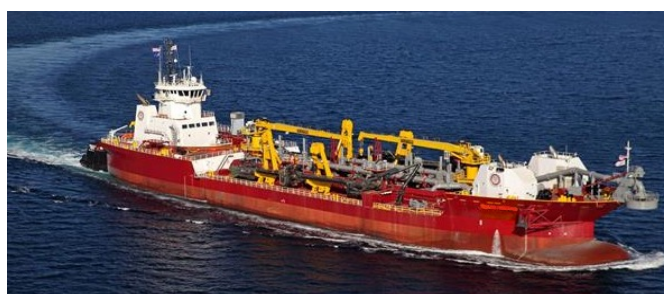
**Figure 14** - Hopper dredge marine vessel.

A large, 400-foot-long hopper dredge ship, similar to the one pictured in Figure 14 operating in the Gulf of Mexico, was powered by three diesel engines that experienced a series of fuel injector failures after receiving fuel. The ship’s log showed the vessel lost approximately 22 injectors and, at one point, all propulsion was temporarily lost as the vessel was coming

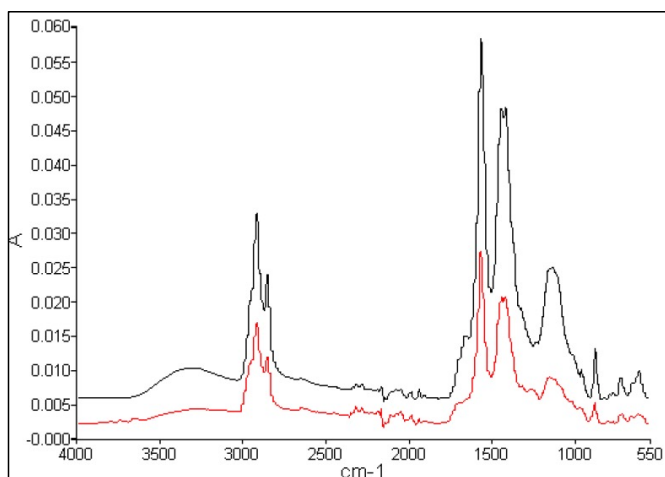
FTIR spectrum of all deposits, including the surface of the fuel filter, showed similar chemical structures. Representative spectra (shown in Figure 20) indicated “fatty acid soaps.” Elemental analysis of the deposits showed the present of sodium and/or calcium. These are the main counter ions in the fatty acid soap detected by FTIR.

**Figure 20** - FTIR spectra of deposits on stuck fuel injectors.

It was concluded that the soap deposits were likely responsible for the improper function of the injectors. Additional information regarding fuel processing and fuel additives led to the conclusion that the formation of the soap deposits was likely the result of two classes of contaminants in the fuel—acidic corrosion inhibitors; introduced during the refining, storage, and/or transport process prior to delivery to the vessel; and sodium and/or calcium. Possible sources of sodium and/or calcium include contamination from sea water, salt-dryer filters used in the processing and refining of fuel, and chemicals used for cleaning the vessel’s fuel tanks. The third component that combined to form the soap deposits is the diesel fuel itself and/or biological growth (if water is present in the fuel). The soap formed was viscous and highly polar, capable of adhering to metal surfaces and “gumming up the works.” The presence of copper and zinc can accelerate such a process. Standard fuel tests currently in use were not effective for identifying the cause of the problem because the quantity of contaminants necessary for carboxylate formation which cause the injector failure was extremely small. The immediate solution to prevent injector failure was to prevent or remove formation of the deposits rather than try to identify the presence of contaminants in the fuel.

Following the presentation of the findings, the diesel engine manufacturer began developing a test for the fuel that may reveal the presence of the reactants which led to the soap formation in the above scenario. Preliminary tests on a fuel sample from the vessel in question showed the presence of the reactants to be outside of the normal range, likely causing the formation of soap deposits. The engine manufacturer is continuing to refine test methods and hopes to soon have a commercially available field test.

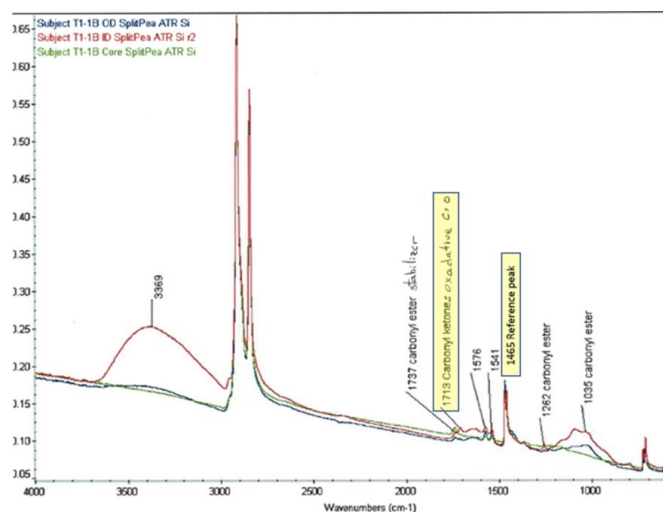
degradation. In particular, it is used to identify carbonyl groups that can be used to quantify the extent of oxidation through what has been termed the "Carbonyl Index" or CI. The carbonyl index can be calculated by taking a ratio of the height of the ketone C=O peak 1713 cm<sup>-1</sup> to the height of reference peak of the backbone of the polymer 1465 cm<sup>-1</sup> (Figure 23). Research has shown that carbonyl indices of the interior of polyethylene pipes below 0.02 indicate no significant oxidation while a CI above 0.1 denotes severe oxidation and embrittlement that may lead to pipe failure.

**Figure 23** - FTIR spectra showing carbonyl and reference peaks for determining the "Carbonyl Index."

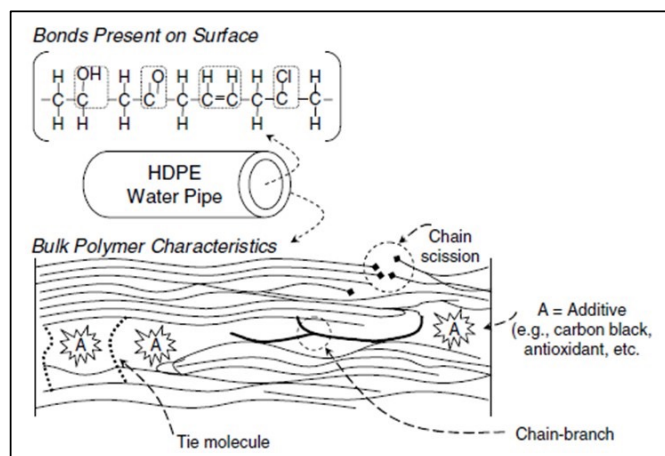
Most polymers, including plastic pipes, are compounded with antioxidants to prevent oxidation chain scission and the loss of molecular weight and mechanical properties. Antioxidants are sacrificial additives included in polymer formulations to counteract the oxidative effects of service environments. In water distribution pipes, the finite supply of antioxidants included in the pipe formulation is consumed by oxidation reactions. They can also be washed off the pipe surface by flowing water. The antioxidants are somewhat mobile and able to migrate within the pipe wall from the core to reaction regions on the inner diameter surface.

**Figure 22** - Representation of chemical bonds and degradation pathways of polyethylene pipe in chlorinate water.
